FAA Center for Aviation Systems Reliability

## UVA-Induced Fade of Penetrant and FPI Indications

Center for Nondestructive Evaluation

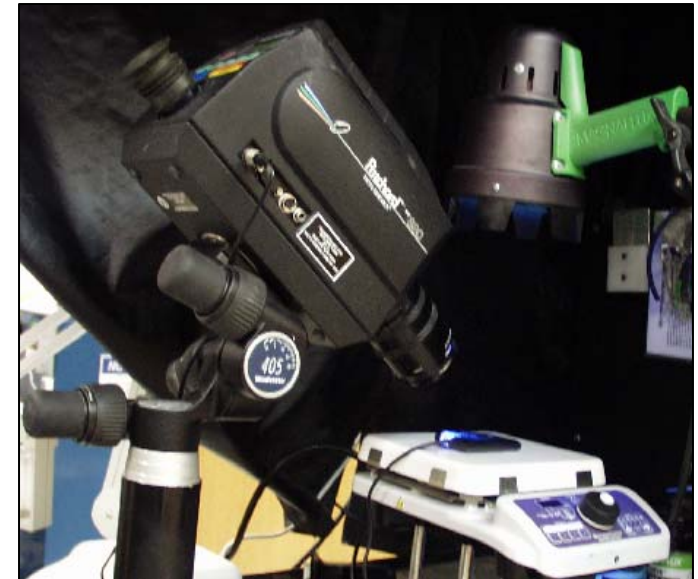
Photometer, UVA source, and digital hotplate used for some runs

- Brightness measurements were made with a Photo Research PR-880 photo-spotmeter
- UVA intensity measured with Spectroline DSE-100X and broadband DIX-365 sensor
- UVA illumination provided by:
  - 100W mercury vapor (a)
  - 35W gas discharge (b)
  - Twin 40W fluorescent bulbs (c)
  - 100W short-arc mercury bulb (d)

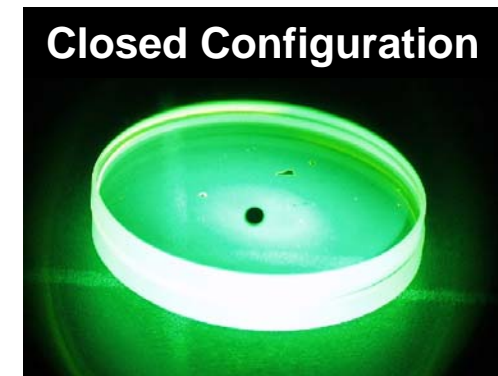
Two-disc penetrant sandwich effectively removing air interaction

- Either 1 (open configuration) or 2 (closed configuration) fused silica discs were used to control and individually measure the effect of UVA, heat, and airflow on photobleaching
- UVA intensity ranged from 1,000 to 74,000  $\mu\text{W}/\text{cm}^2$  (estimated using inverse square law)
- Heat was provided by a hot plate set to 150°F
- Approximately 800 ft<sup>3</sup>/min airflow was provided by a fan
- Closed configuration had penetrant filling interstice between two discs to approximate testing in a vacuum environment

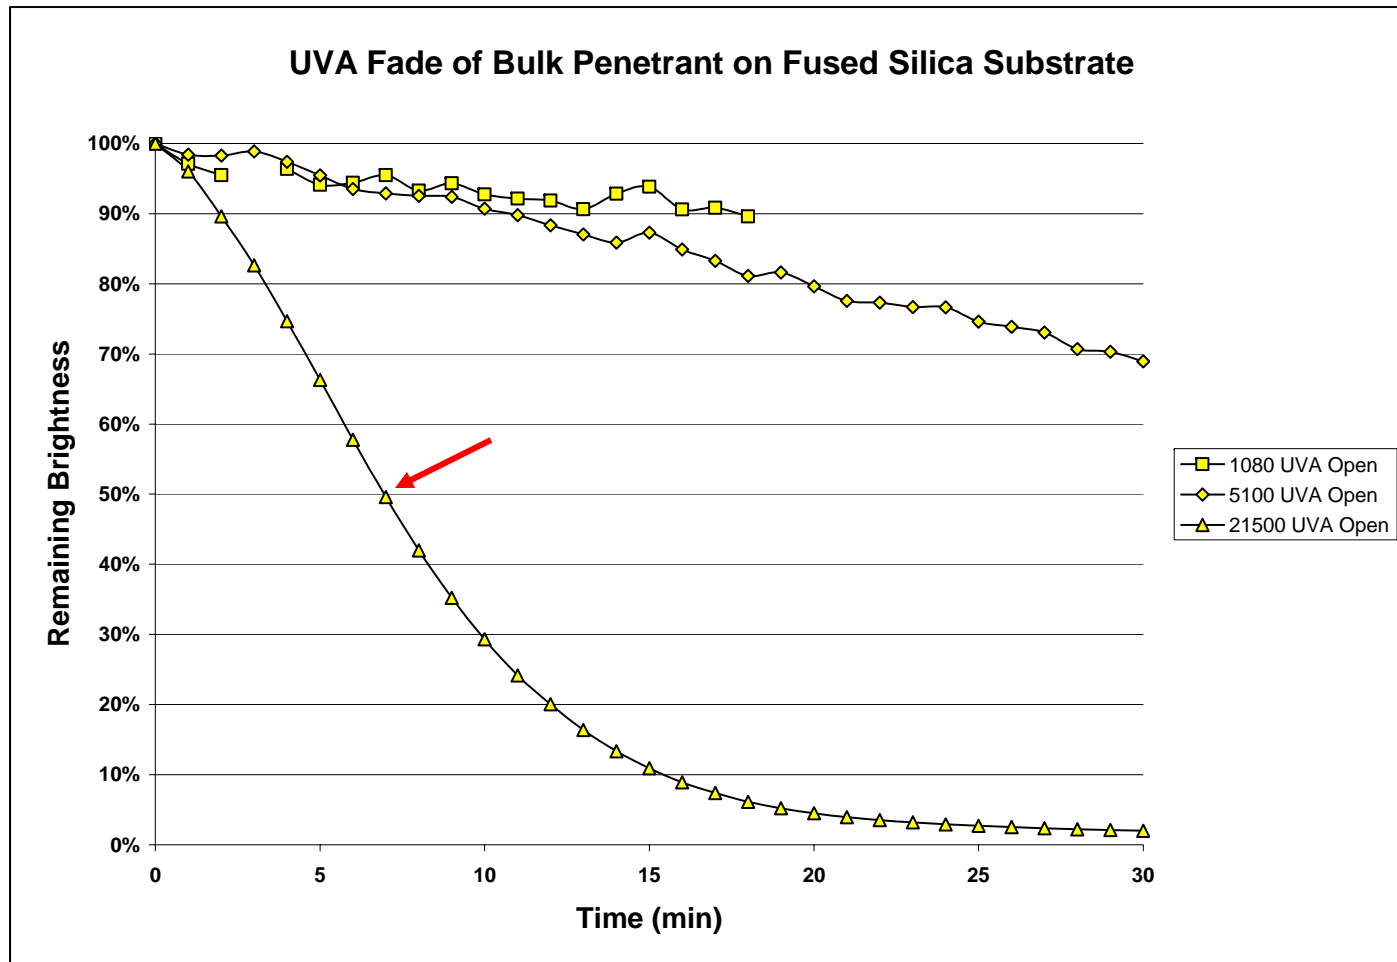
**UVA Intensity: 20,000  $\mu\text{W}/\text{cm}^2$  – Open Configuration**

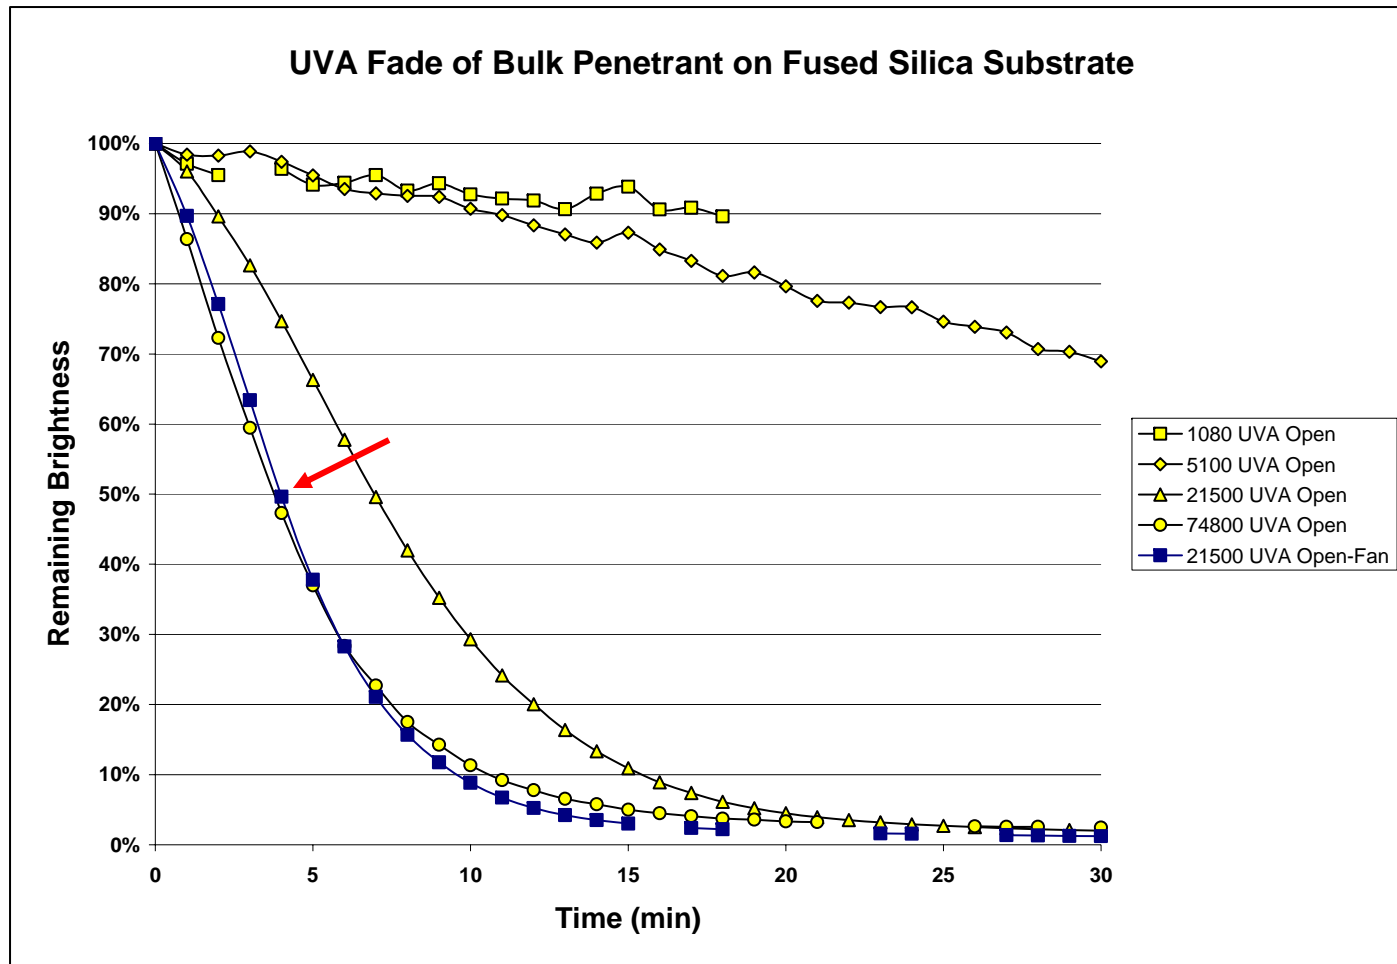
**UVA Intensity: 20,000  $\mu\text{W}/\text{cm}^2$  – Open + Fan**
