# **Progress review of the bolt hole eddy current POD study - Design of the experiment**

Z. Liu, M. Yanishevsky, A. Fahr, C. Mandache

NDE-SMPL-IAR-NRCC

March 9, 2006 Atlanta

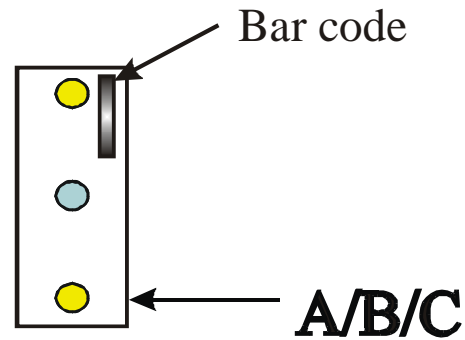
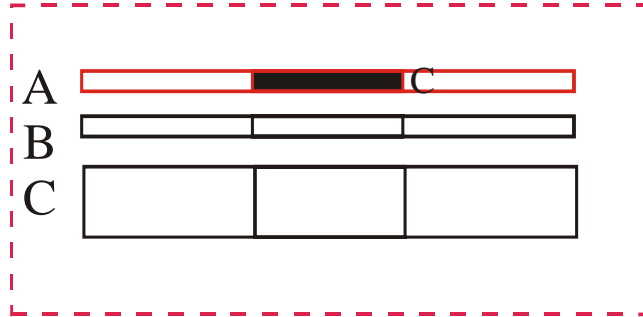
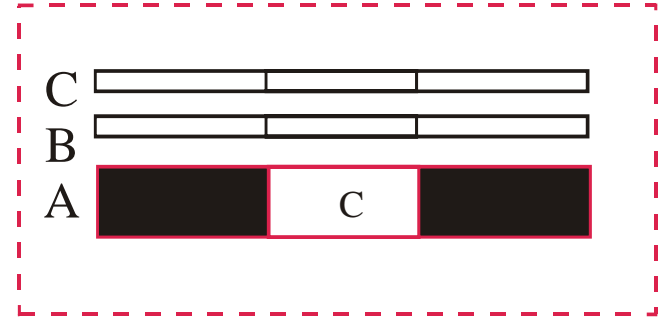
# Plates organized in a reference standard unit

3 pieces; only one piece with crack (A)

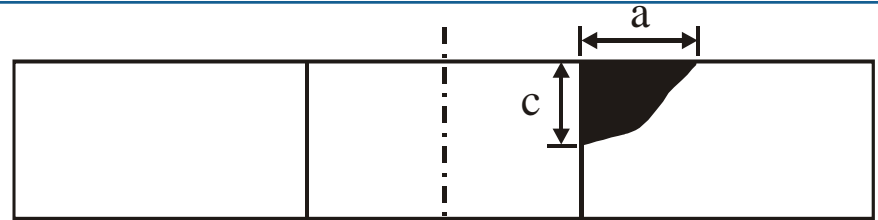
Corner Crack

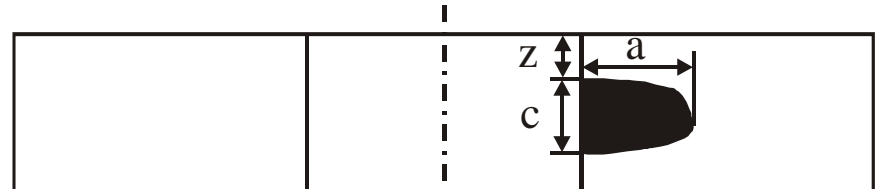
Mid-bore Crack
