Summary of POD Study **Results**

Floyd W. Spencer

ASNT 16th Annual Research Symposium
Orlando, Florida
March 26-30, 2007

AIRLINE MAINTENANCE FACILITY EXPERIMENT

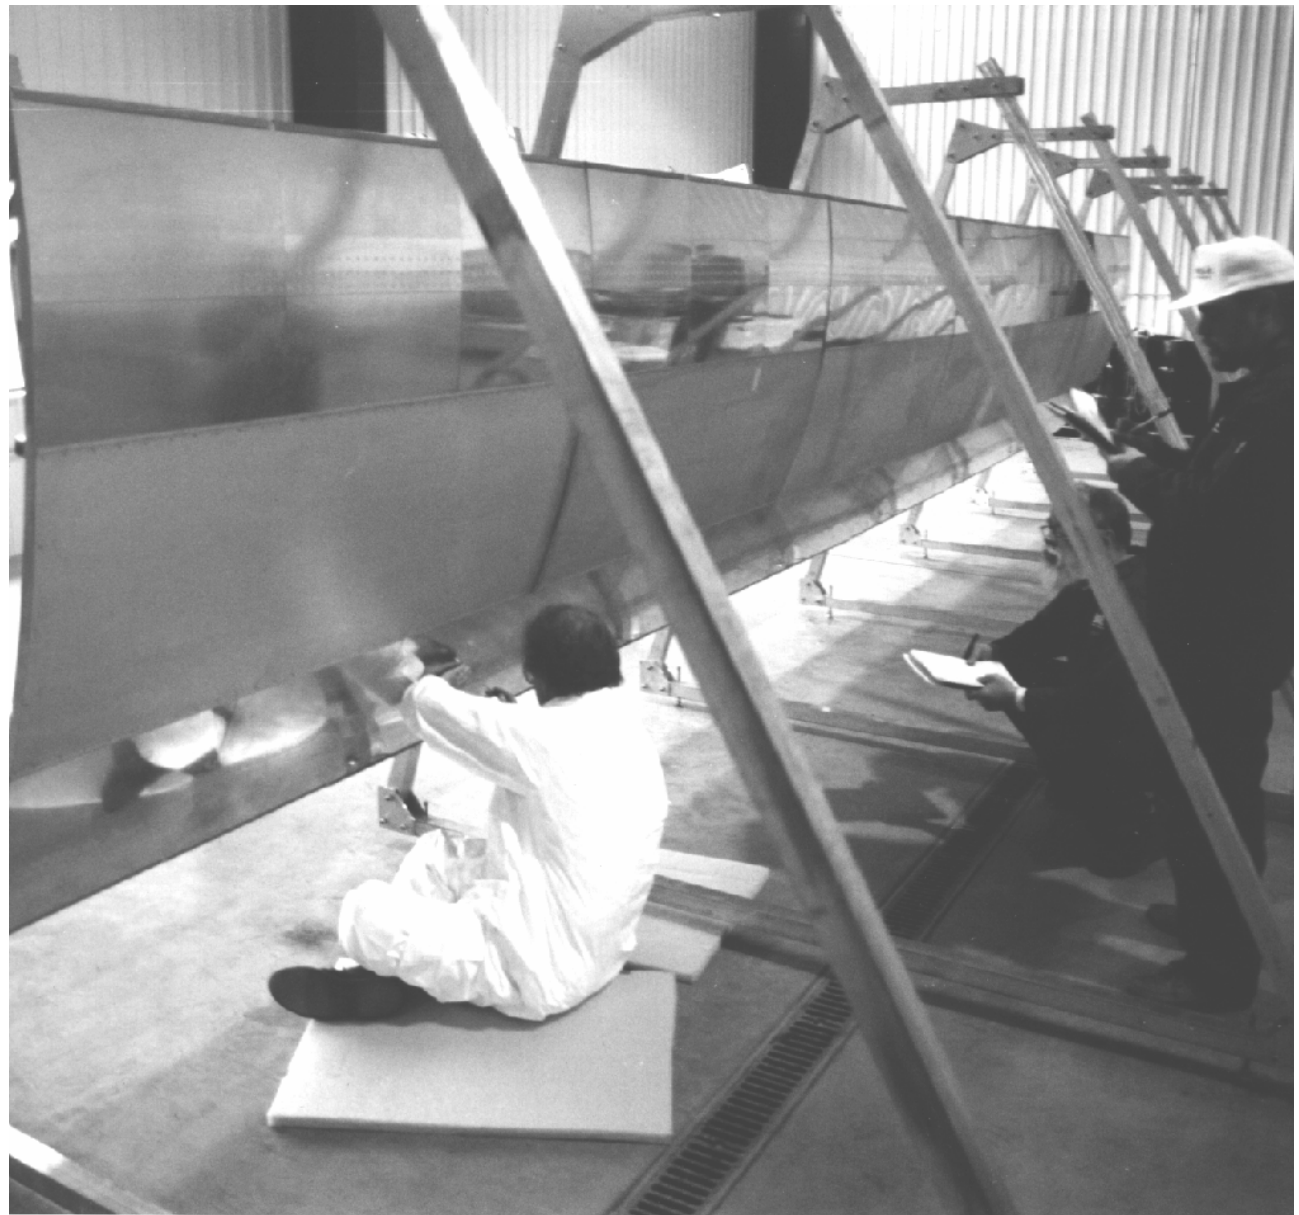
Realism of Inspection
(specimens & location)

Accessibility

Arrangeable layouts
