FPI Cleaning Study Update

FAA Center for Aviation Systems Reliability

David Eisenmann
Center for NDE,
Iowa State University,
Ames, Iowa, USA

Funding provided by the Federal
Aviation Administration as
Delivery Order IA052 as part of
Contract #DTFA03-98-D-00008

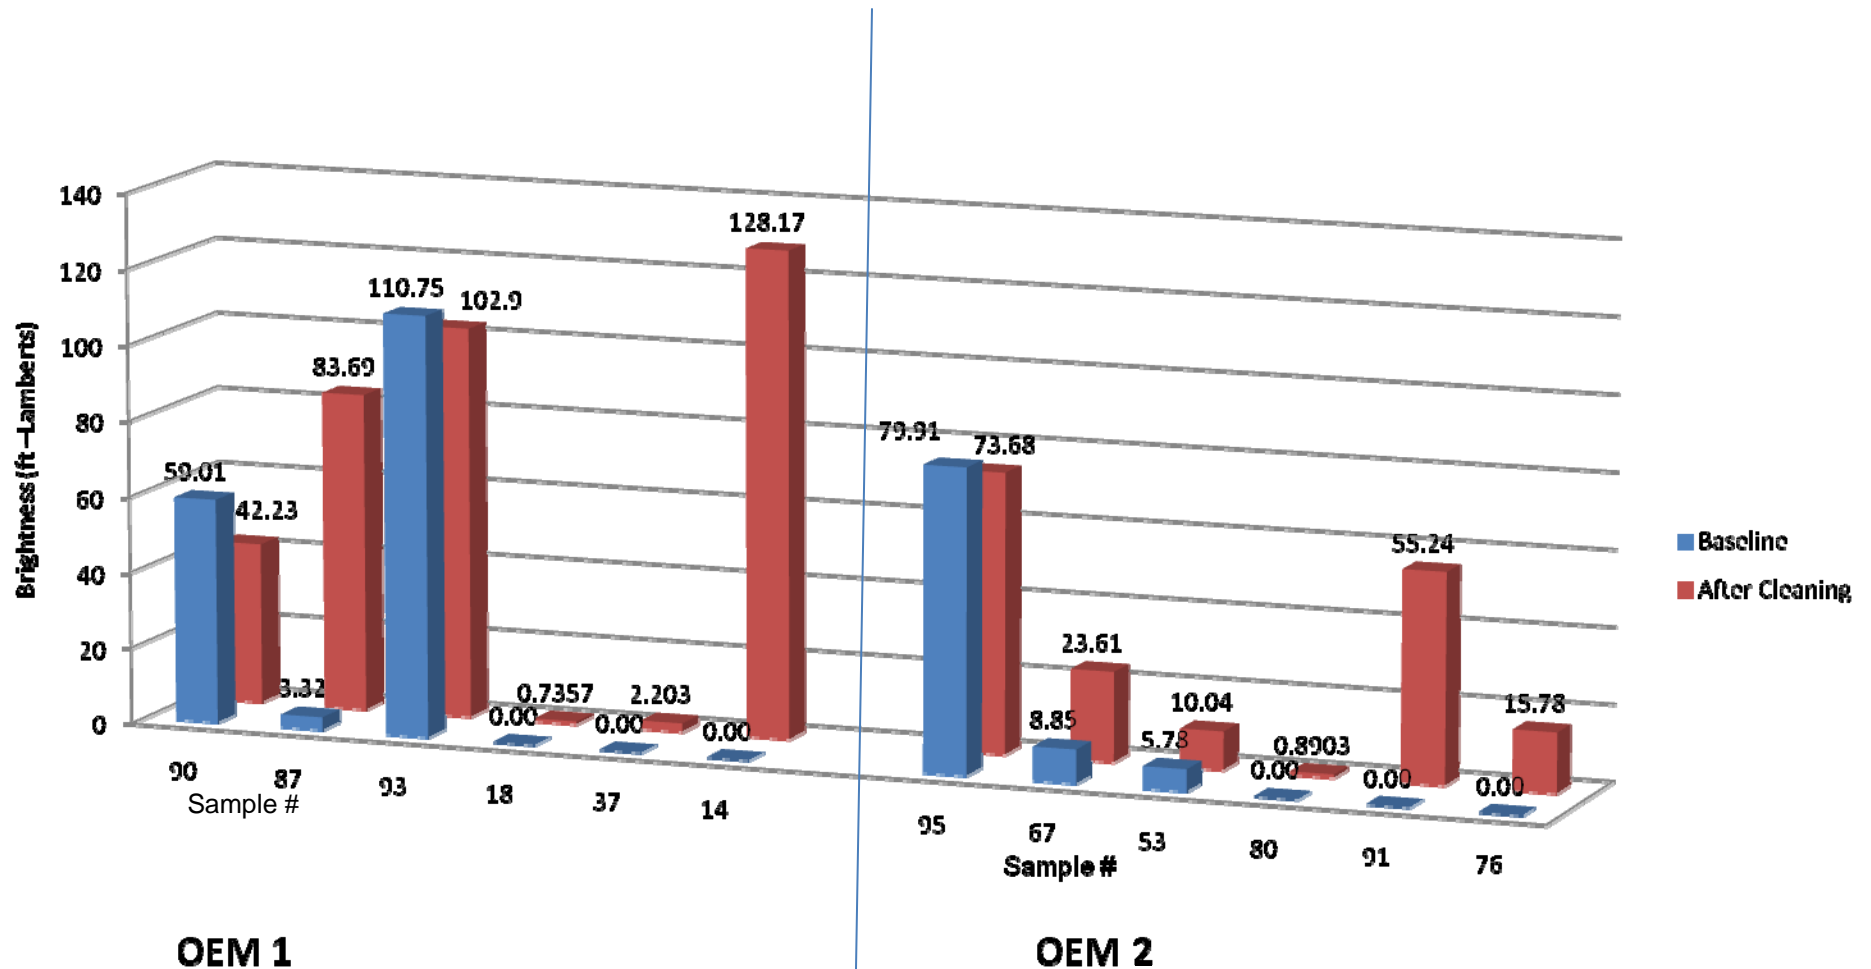
Final Results for Phase I

Baseline VS Post Cleaning

Samples w/o Baseline values were not detectable in the baseline runs but were recovered in the cleaning process

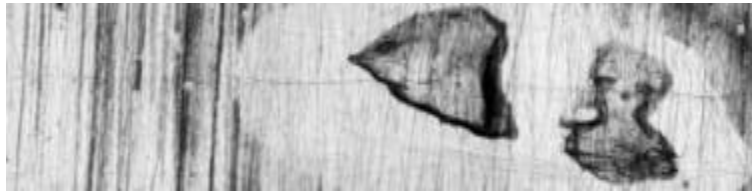
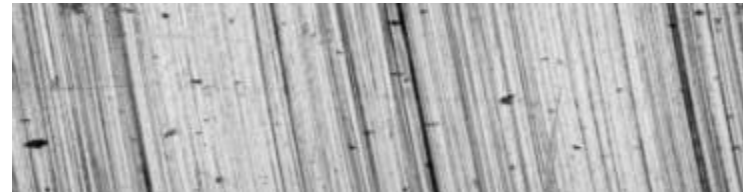
- In two of the samples that were recovered, it appears that the molten salt bath has removed a considerable amount of surface material, making the crack wider than the initial width.

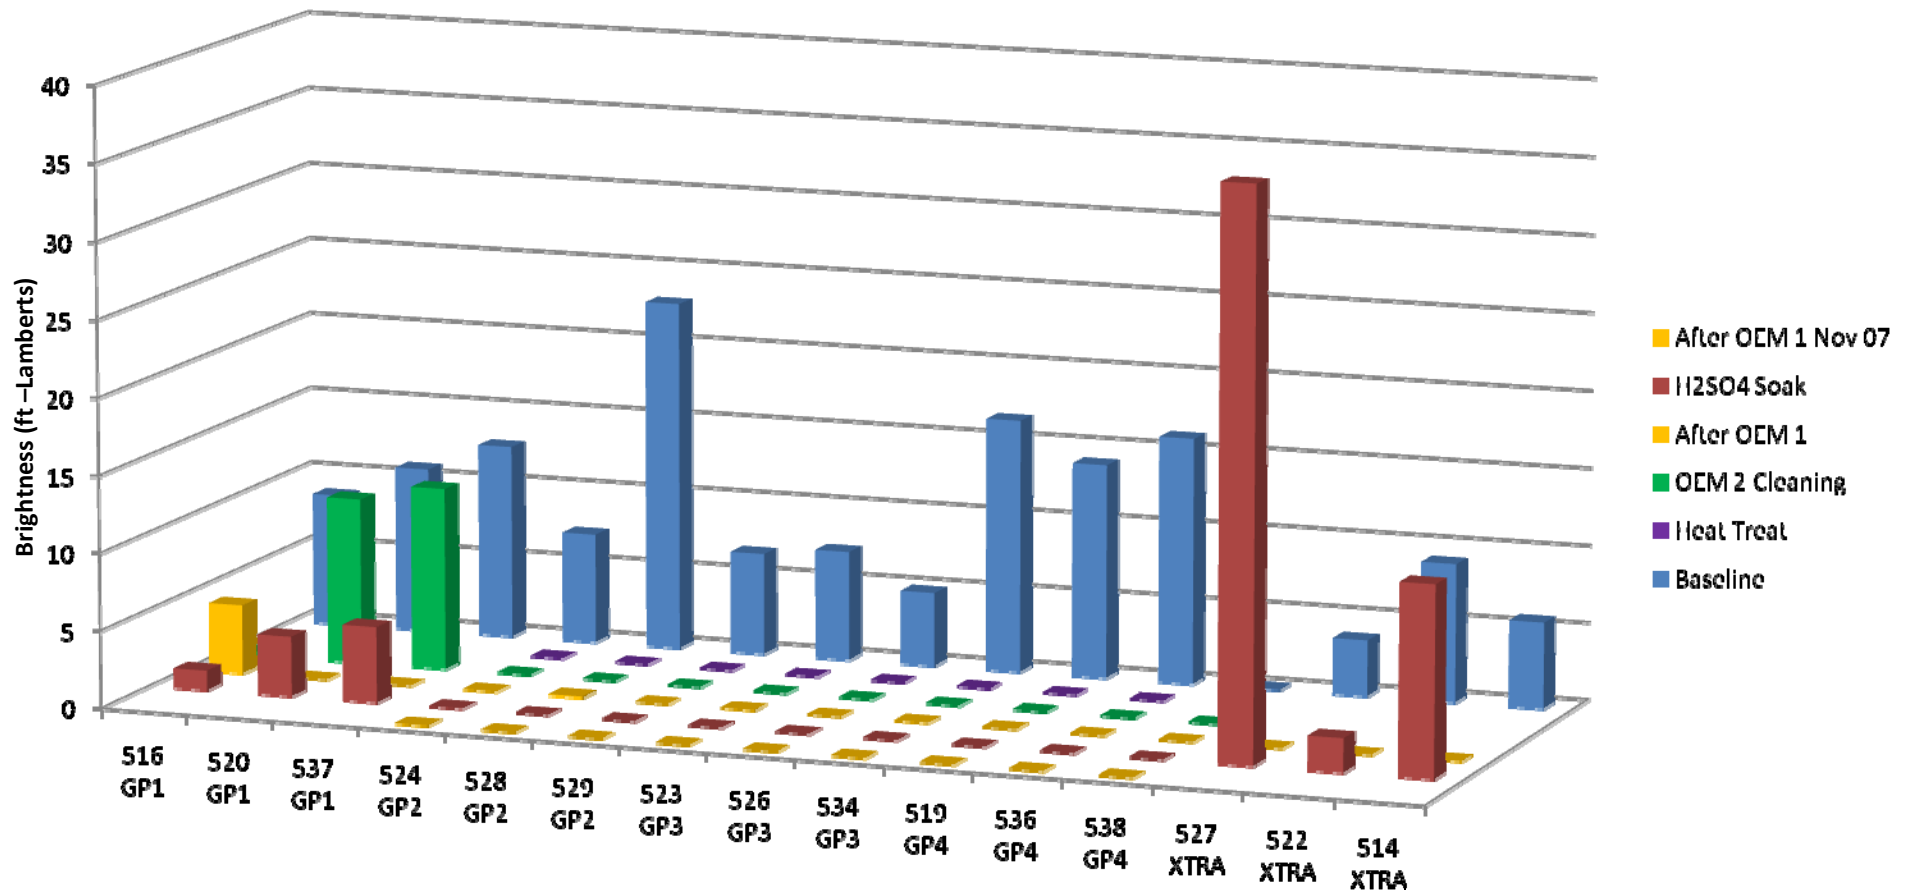
Phase II Results after Cleaning

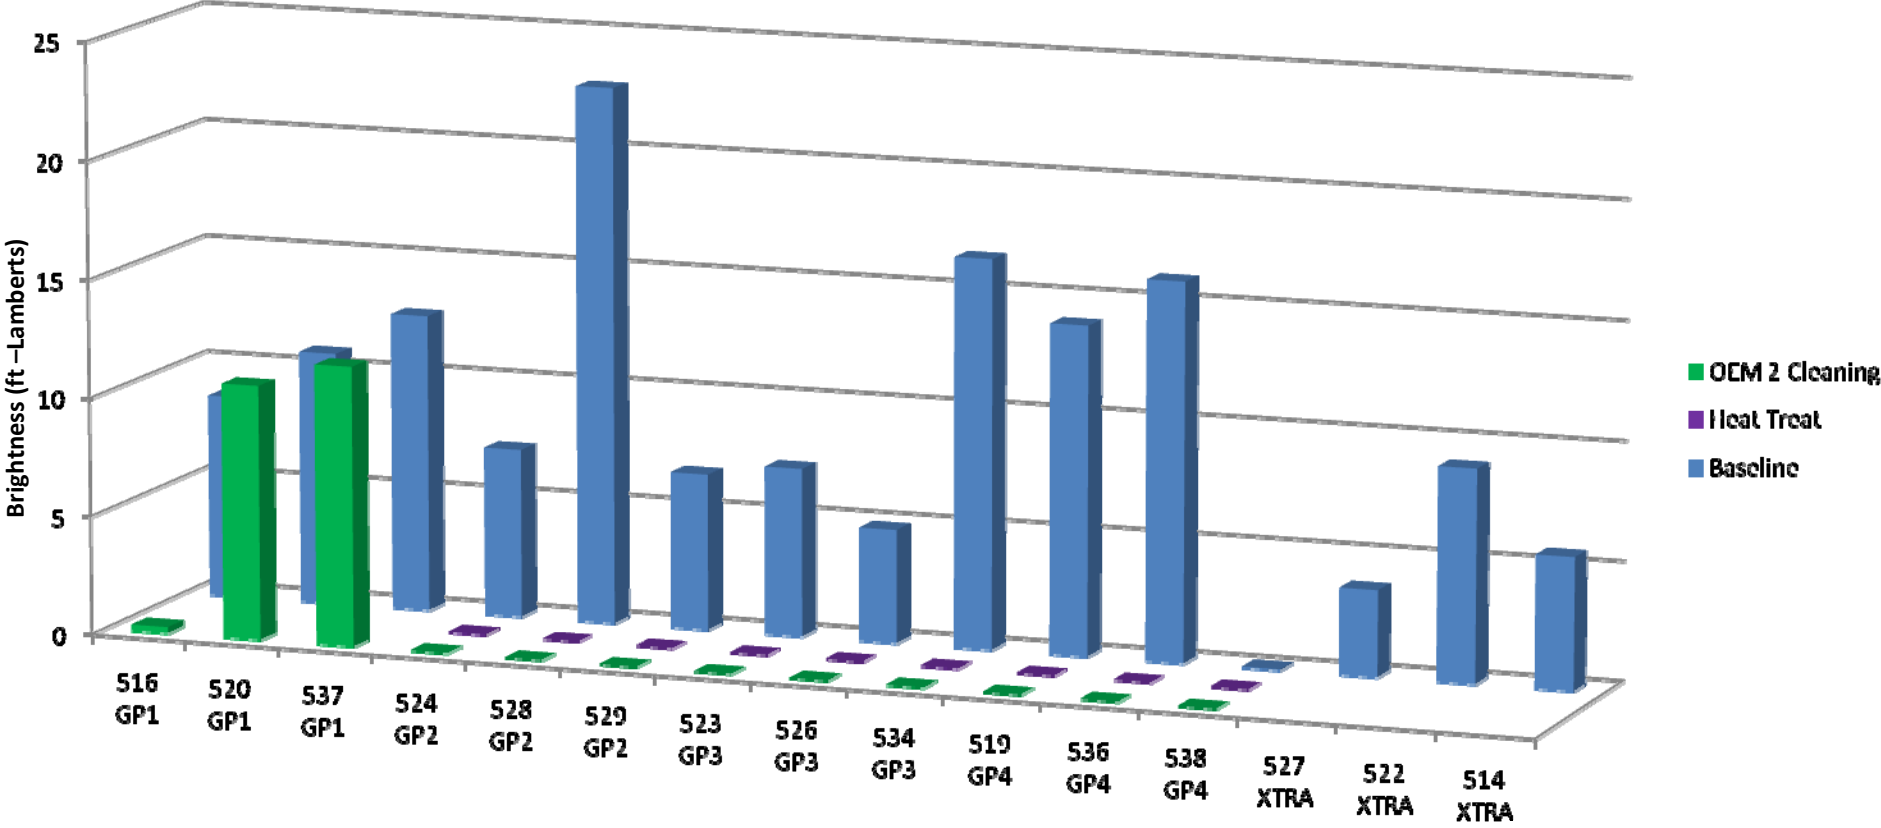
Phase II Results after Cleaning

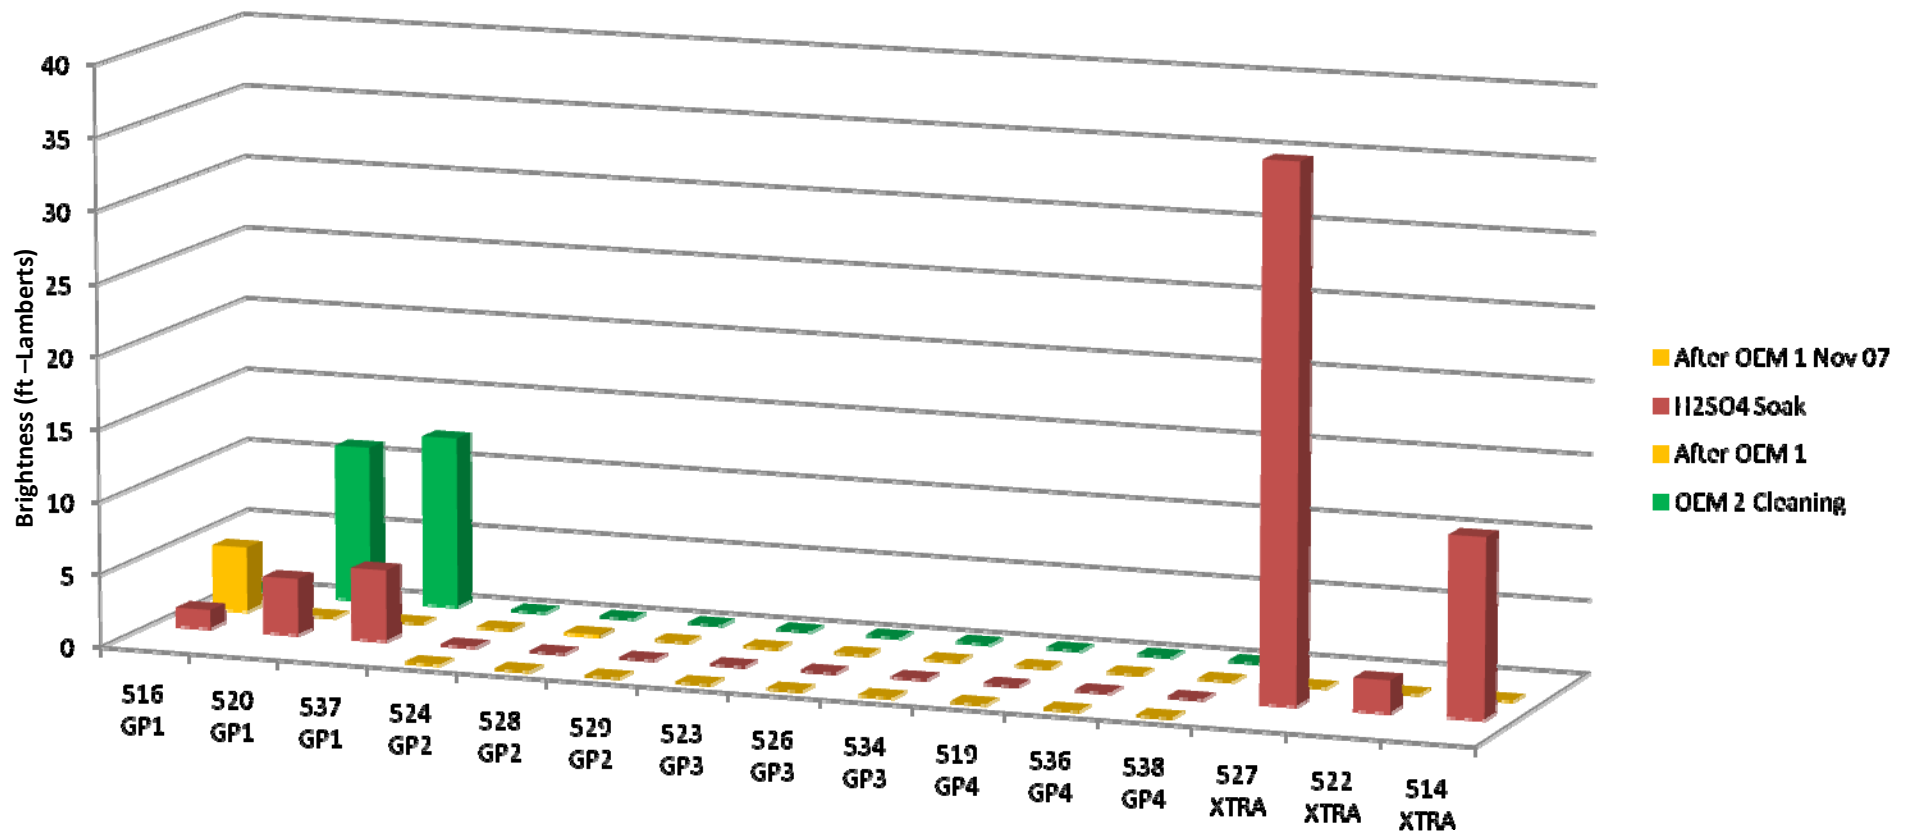
Phase II Results after Cleaning and acid soak

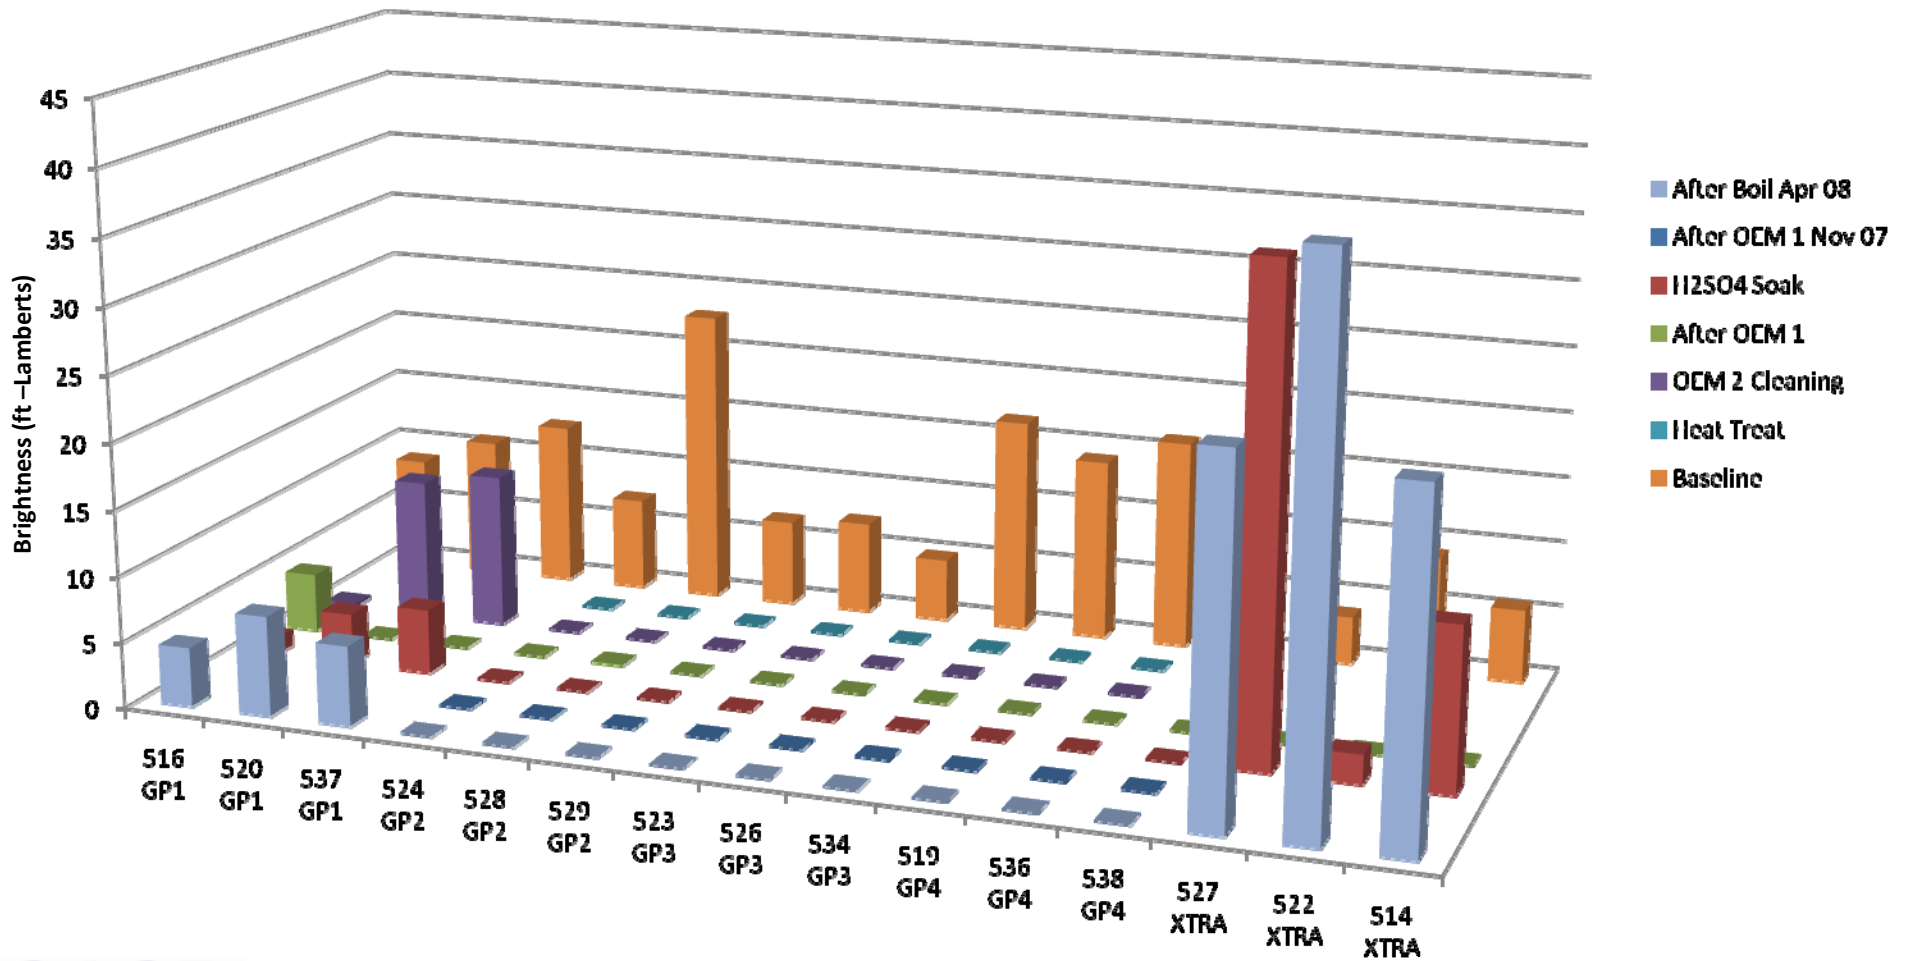
Phase II Results after Cleaning, acid soak and 30 min boil

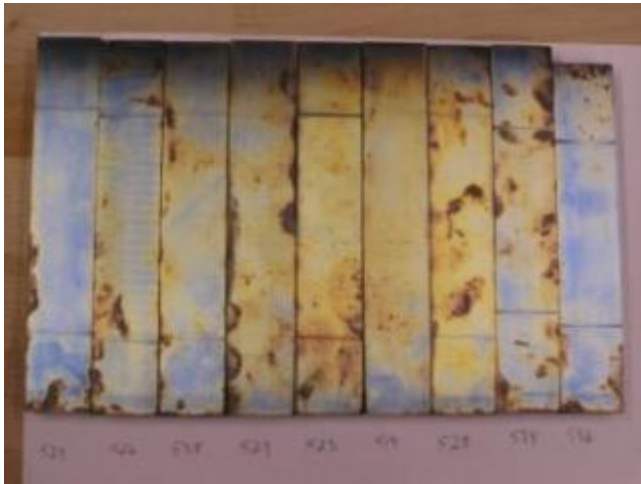
Samples prior to any cleaning efforts

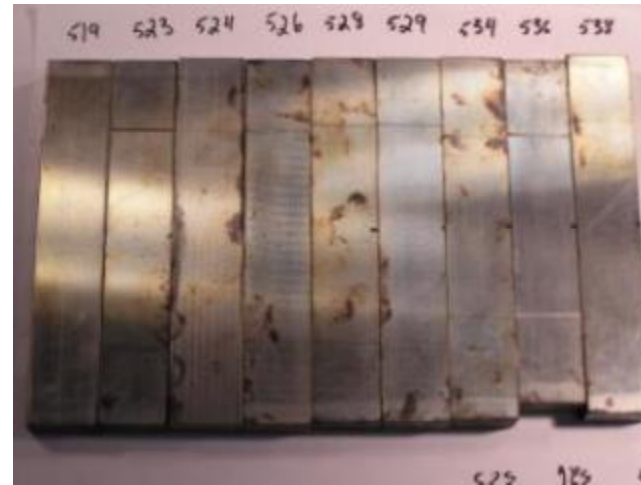
After OEM 2 and OEM 1 Cleaning

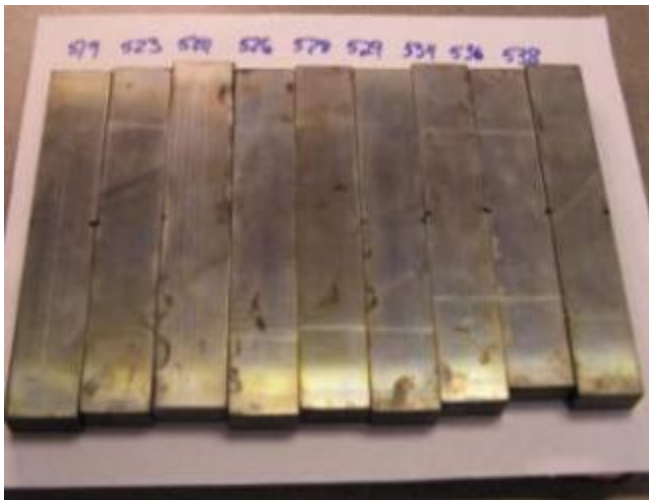
After OEM 2, OEM 1,
and ISU Cleaning

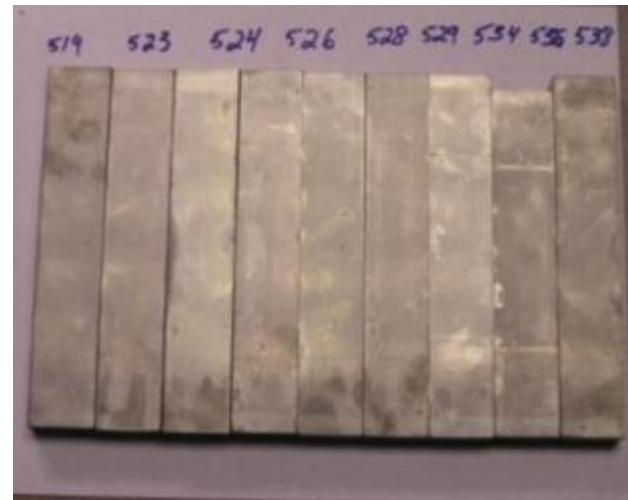
After OEM 1, Nov 07

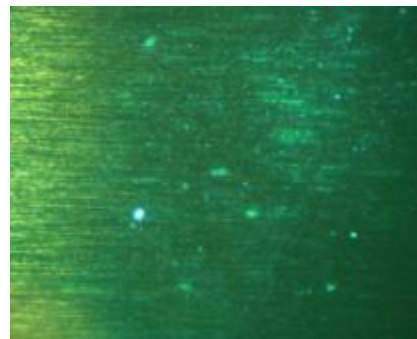
After ISU
B= -0.0065
E=5.29min
No real
indication

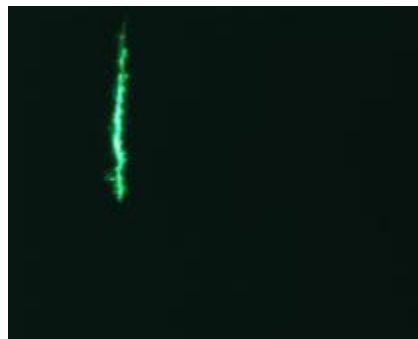
After ISU
B= 12.2608
E=443ms

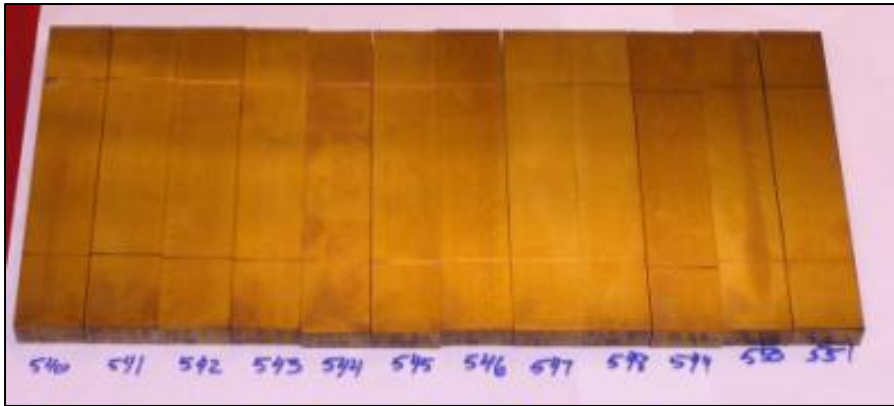
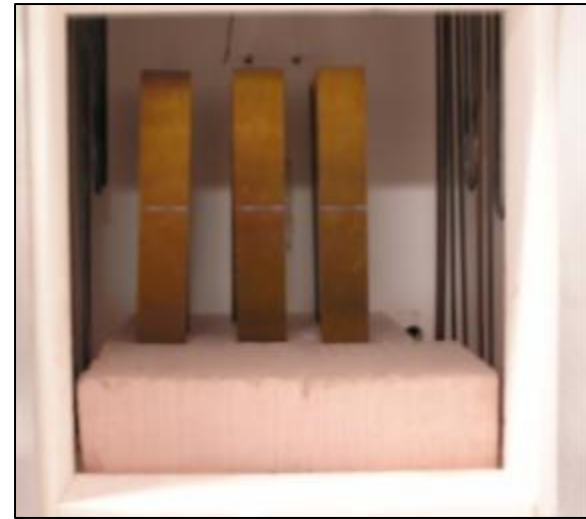
Photo of samples after heat treatment

- Samples were cleaned in acetone in an ultrasonic cleaner for 30 minutes and kept in acetone until placed directly into the furnace.
- Heat treatment was done at 800°F for 96 hours.

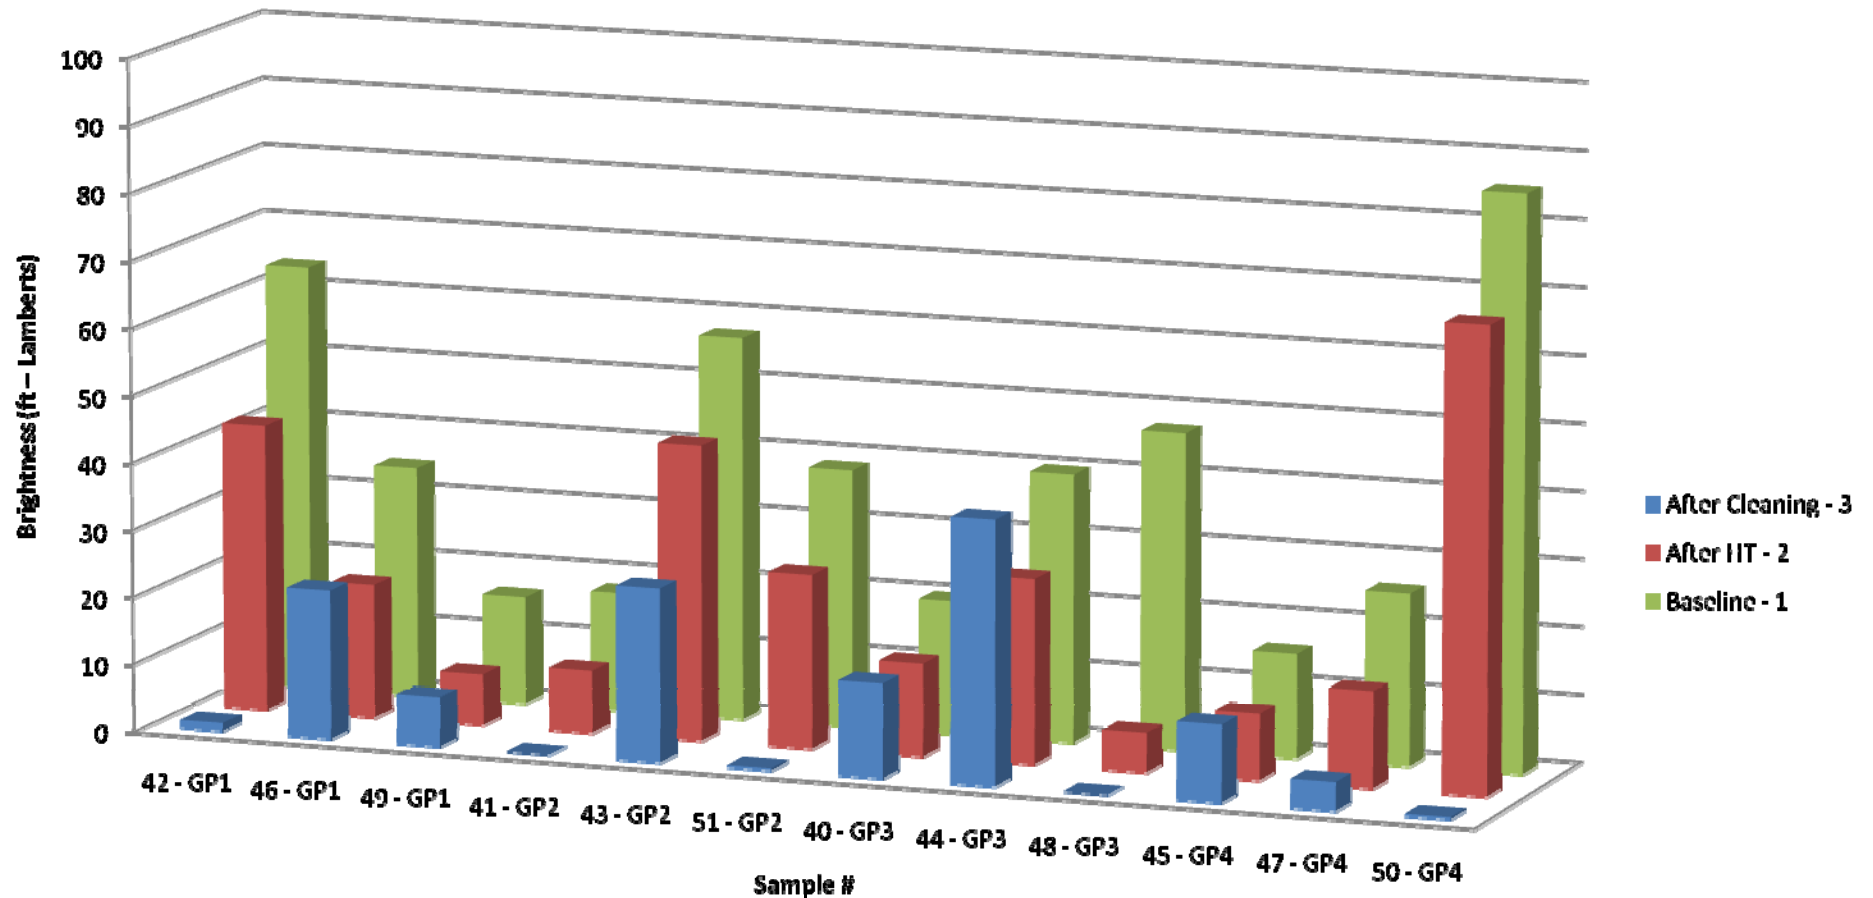
Baseline, Heat Treatment and Cleaning Brightness

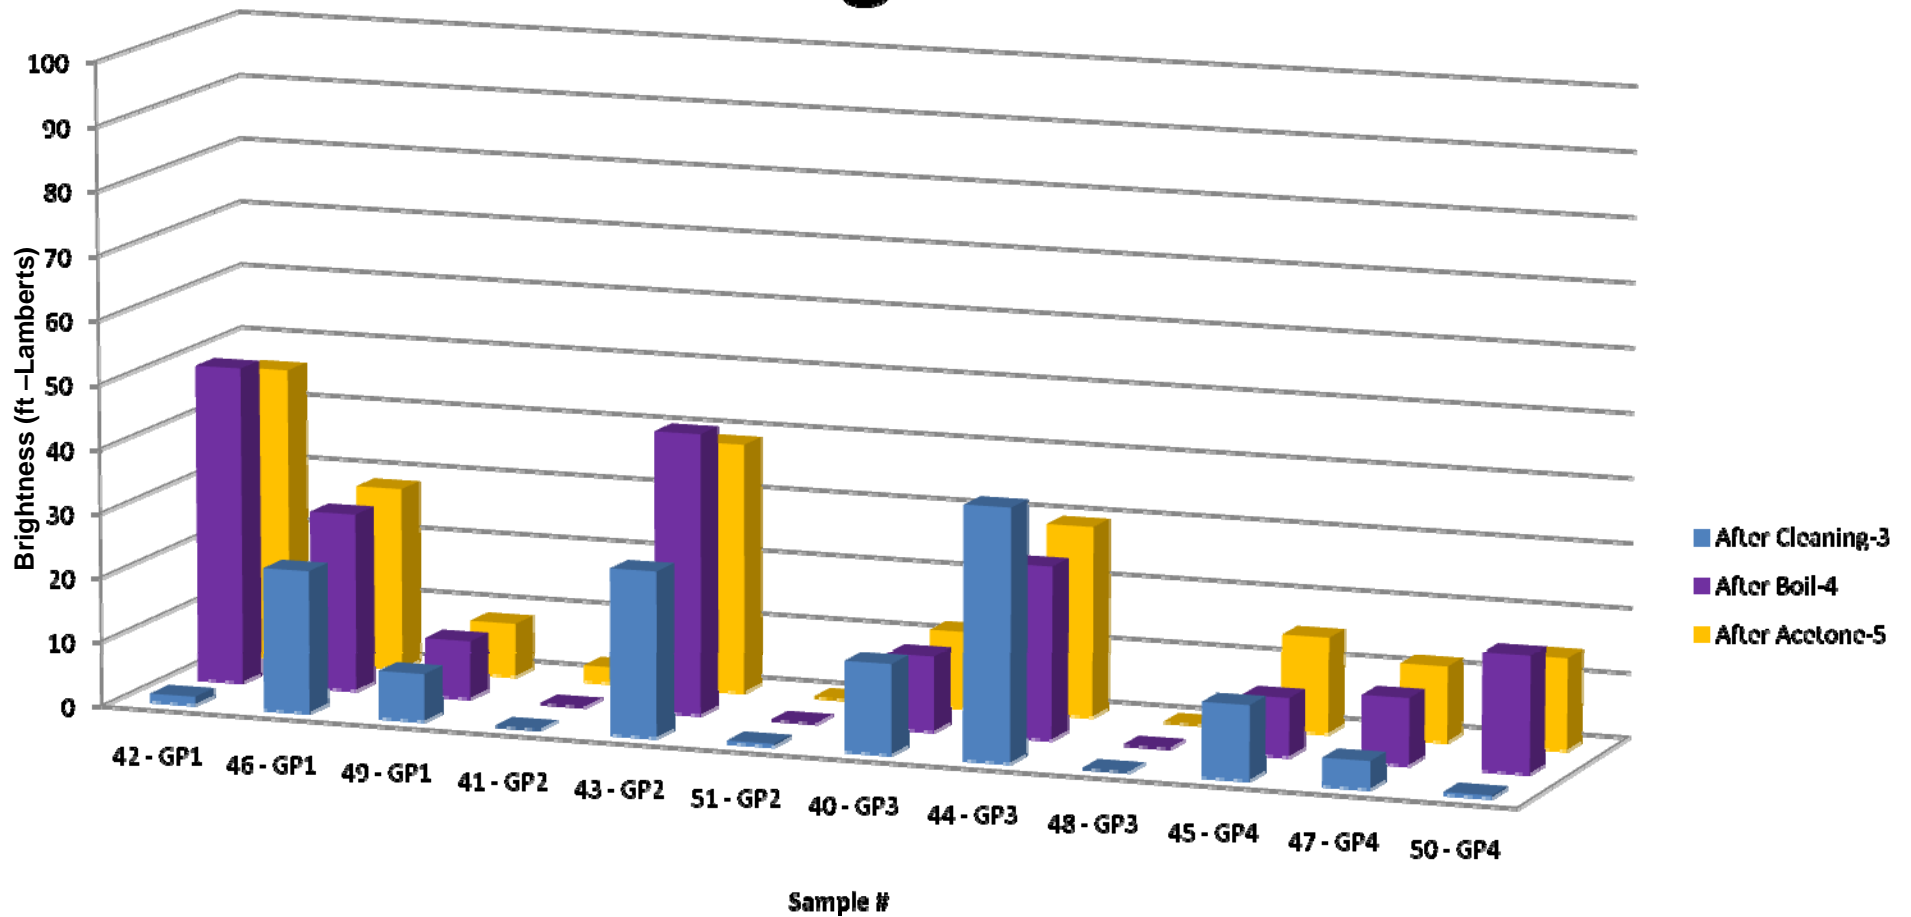
Cleaning, Boil and Acetone Brightness

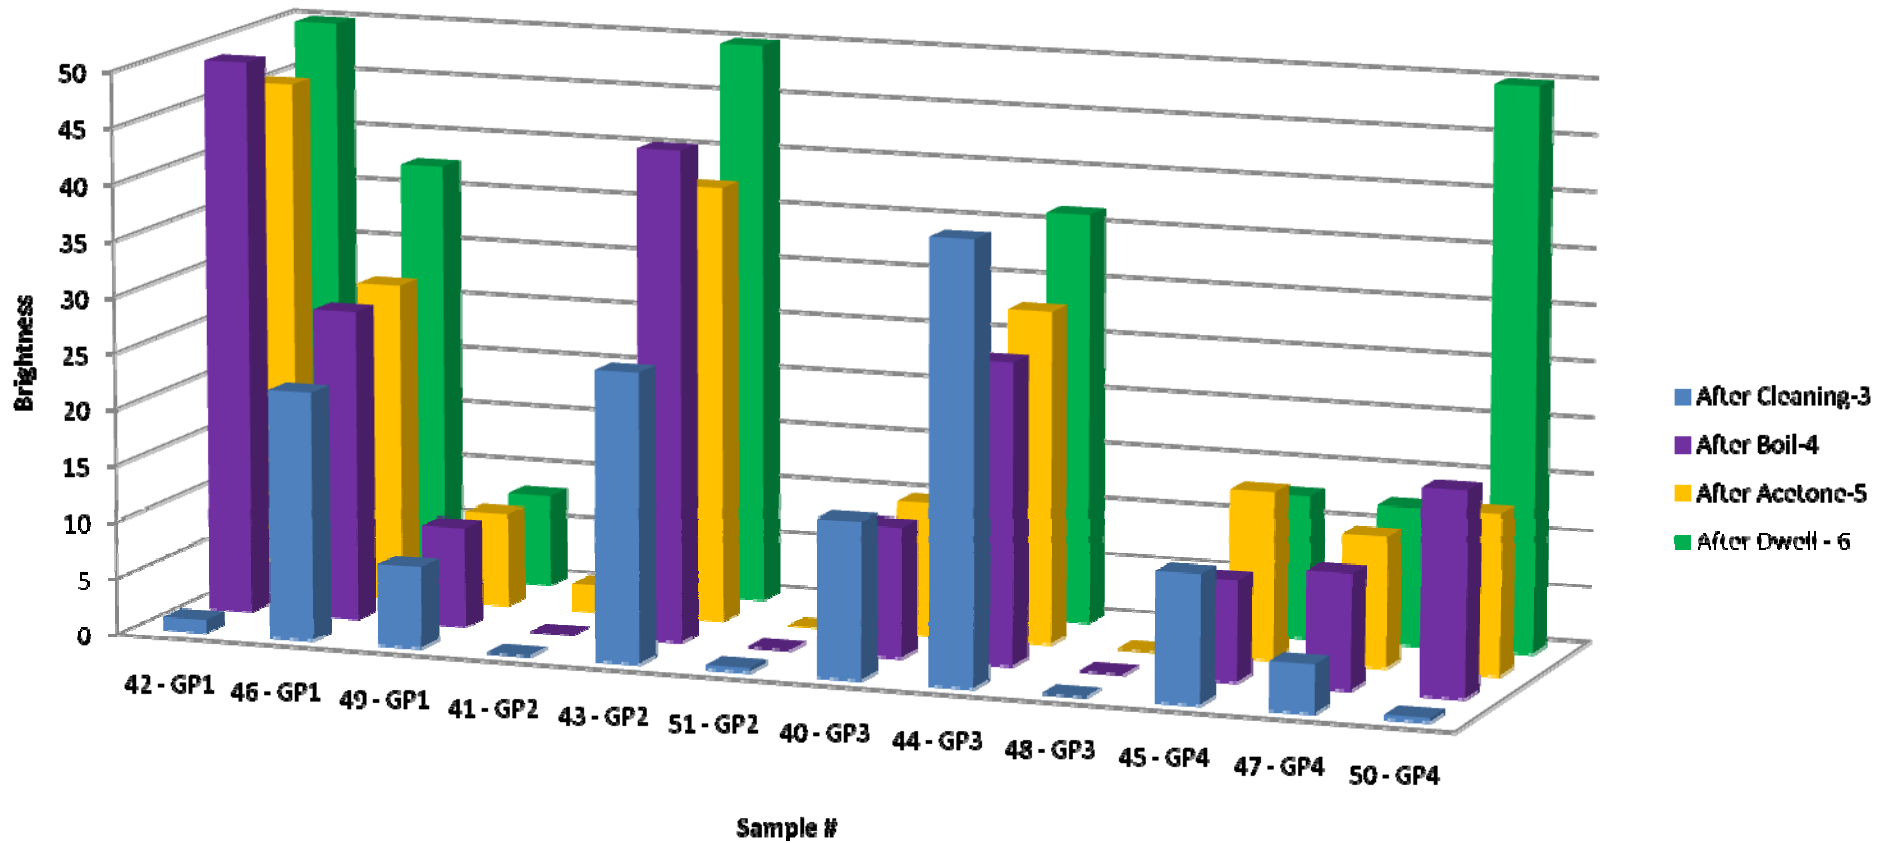
Cleaning, Boil and Acetone Dwell Brightness

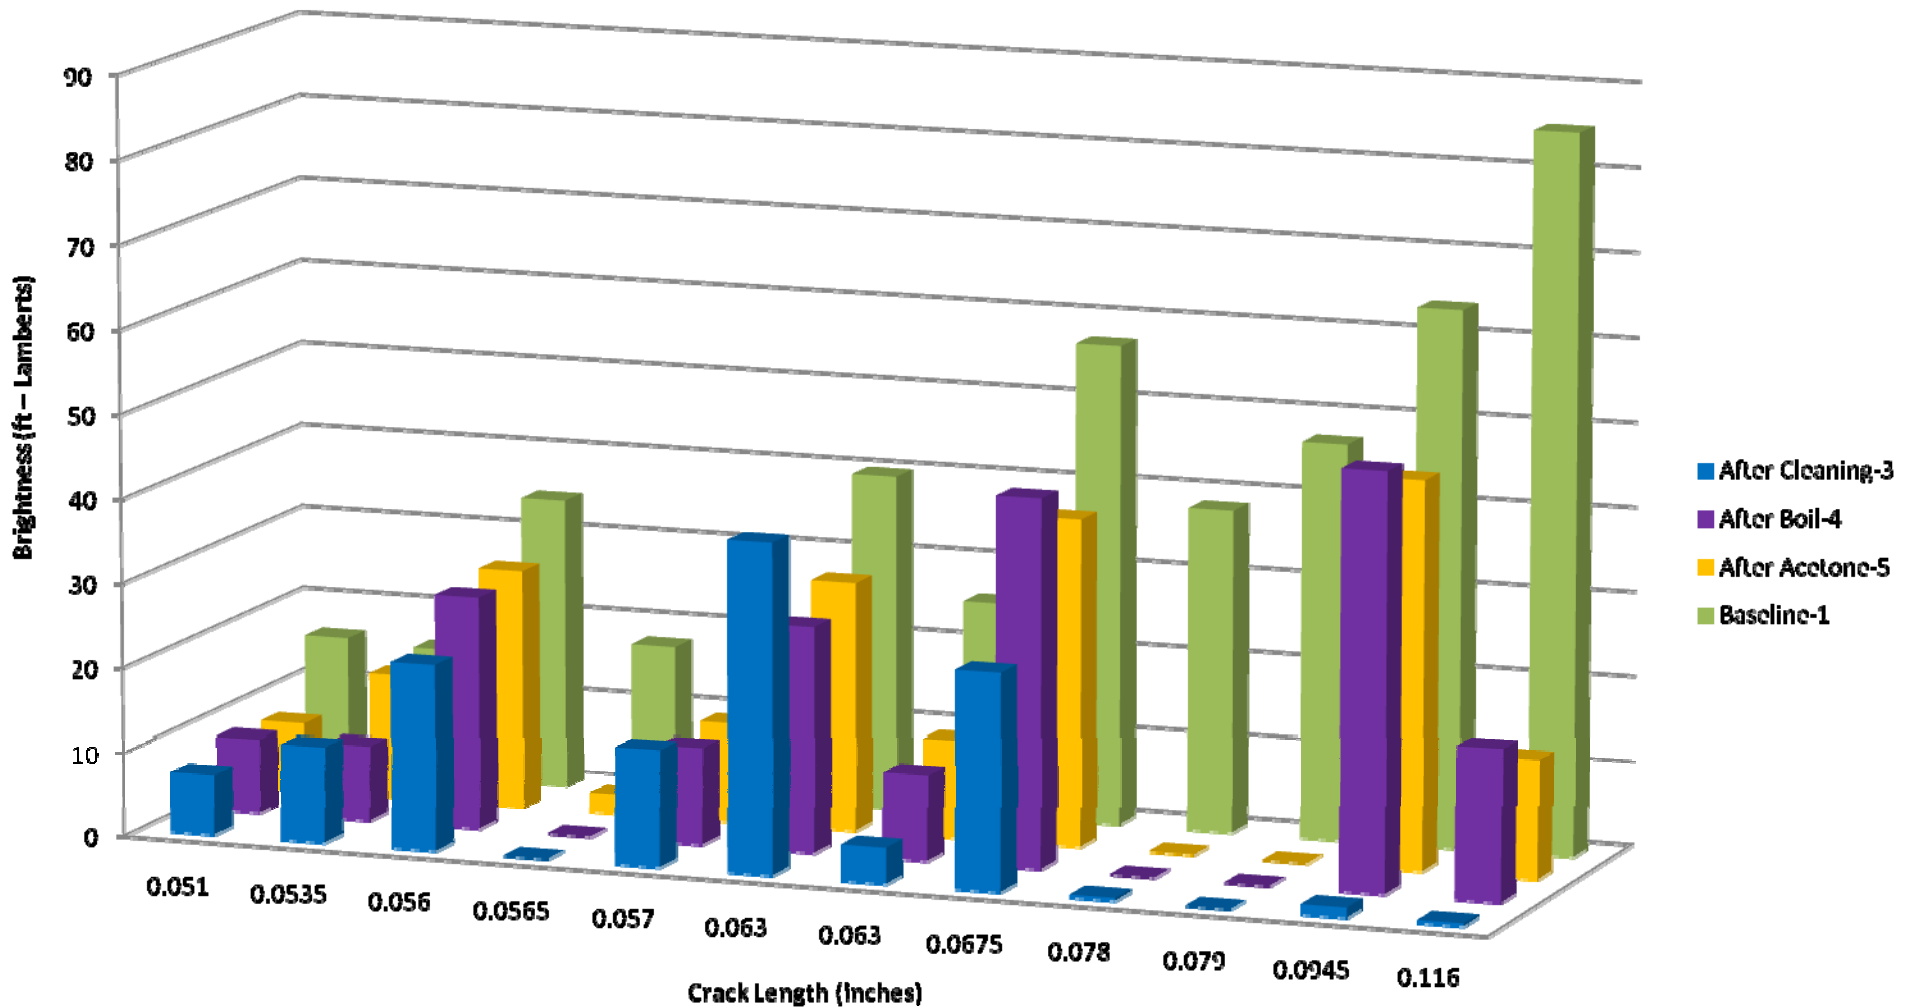
Brightness verses Length

- Brightness of the samples after baseline tended to increase with increasing crack length
- After cleaning, brightness values of the samples decreased in most cases with the longer cracks above 0.070"
- Sample brightness values increased after boiling water and/or 1 hour acetone cleaning

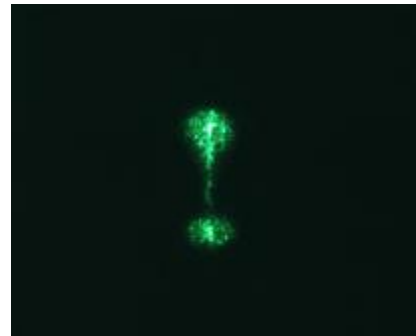
After alkaline clean
B=7.7267
E=1.07s

- 552 shows loss of crack ends in both post alkaline cleaning runs
- 553 was not recovered after the alkaline runs
- 554 lost some brightness after the cleaning, approximately 40%

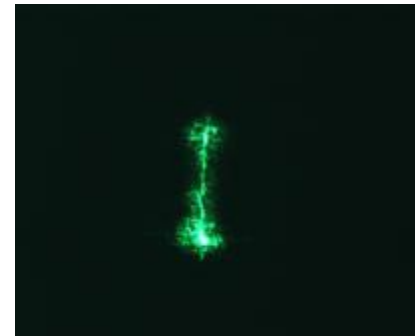
After FPI and Boil
B=15.935
E=443ms
