Model-Assisted POD for Ultrasonic Detection of Cracks at Fastener Holes

Cayt Harding, Geoff Hugo, Sue Bowles

Defence Science and Technology Organisation

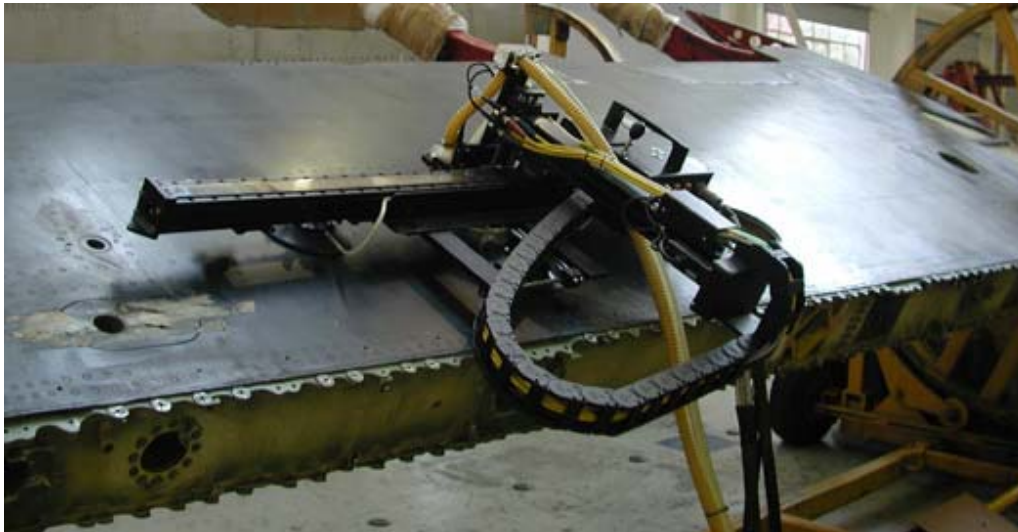
- >100 EDM notches inserted in bore of fastener holes across 2 wings
 - Range of types, sizes and locations
- 4 level 2 NDI Technicians
 - Training recently completed
 - No previous experience interpreting full-waveform c-scan data
- Treat data acquisition and data interpretation phases separately

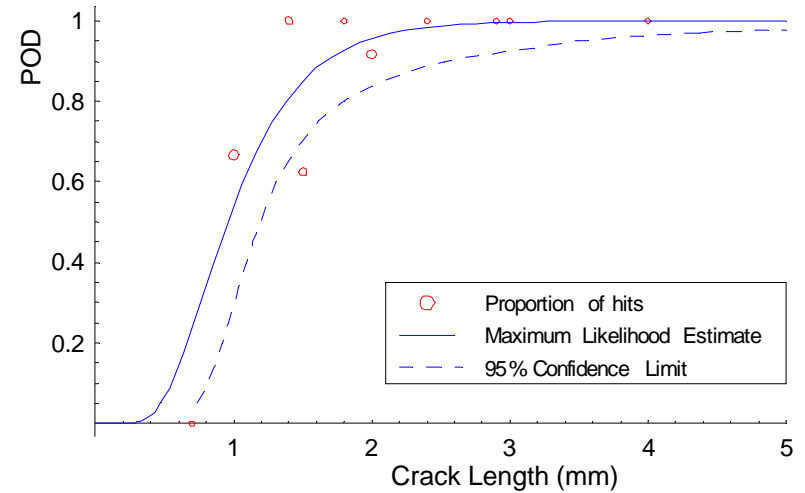
Mid-bore Centre

a_{90} (mm)	$a_{90/95}$ (mm)
Corner	0.5	0.7
Mid-bore centre	1.7	2.5
Mid-bore top	3.3	Not achieved

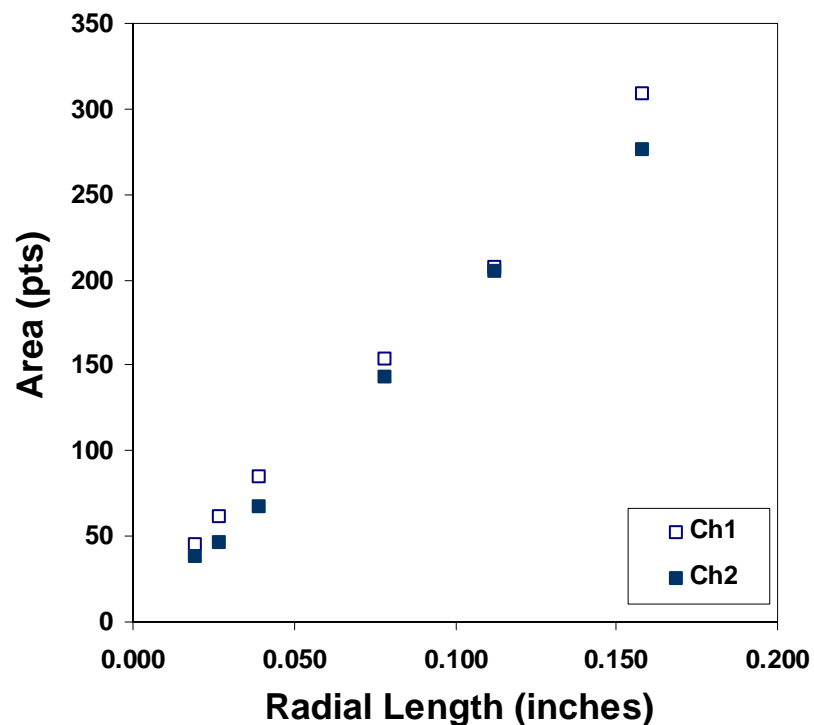
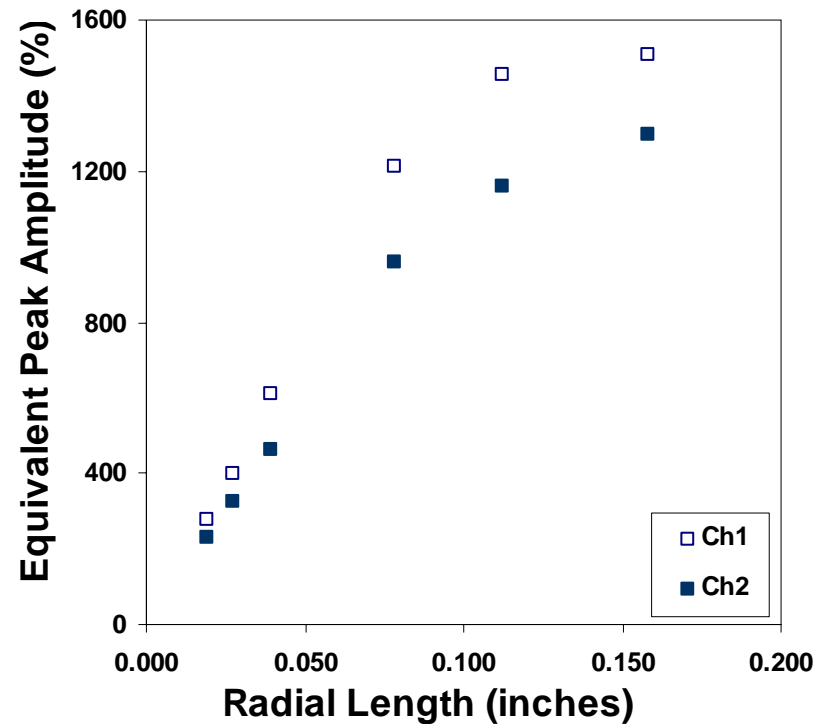
- UT response for corner EDM notches in specimens
 - Corner reflections
 - 0.5" specimen thickness

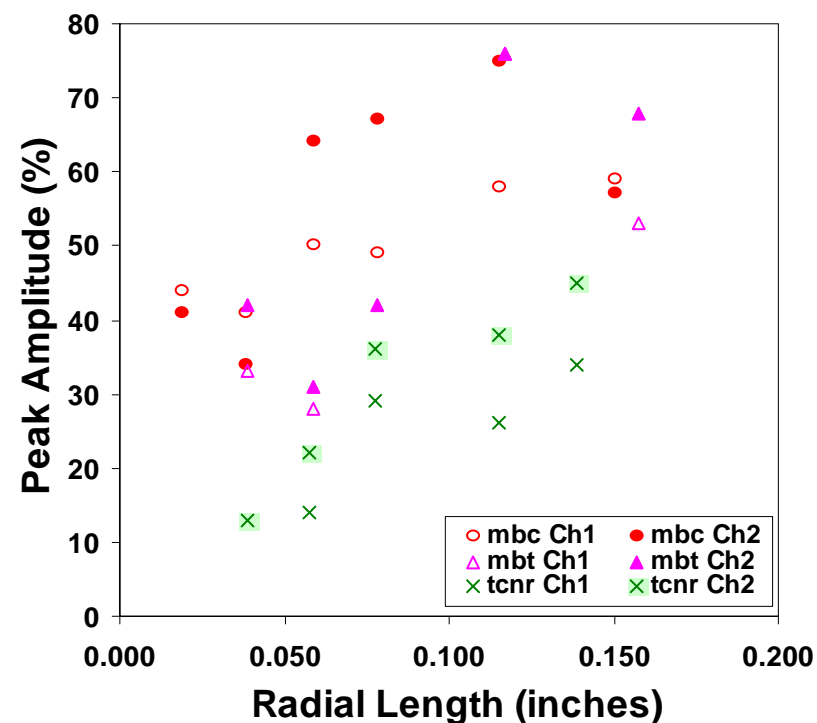
- UT response from mid-bore EDM notches
 - Direct reflection
 - Area measured at lower threshold
