DOUGLAS PAPER
MDC 91K0074

EDDY CURRENT STANDARDS — CRACKS VERSUS NOTCHES

presented to
1991 ATA NDT FOURM
Long Beach, California
September 11, 1991

Douglas Aircraft Company
MCDONNELL DOUGLAS

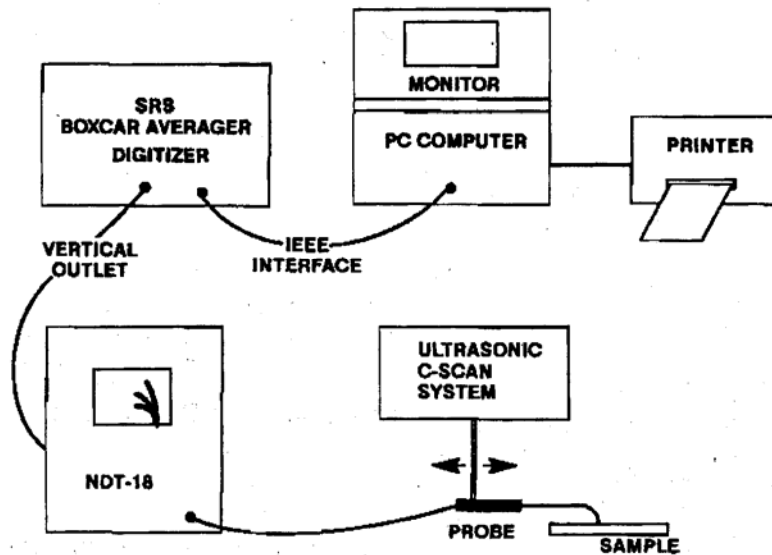
diameter and 127 mm long, had a 90-degree orientation, and was ferrite-shielded. A Nortec NDT-18 eddy current instrument was used for all tests. To achieve maximum response from the notches and cracks, the liftoff was in a horizontal direction on the CRT, and the crack/notch was in the vertical direction. The horizontal gain was set at 1 volt per division and the vertical gain was set at 0.2 volt per division. (The CRT was divided into 8 vertical divisions and 11 horizontal divisions.) The vertical output from the NDT-18 was fed into an SRS boxcar averager, then through an IEEE interface to a PC computer and monitor, and finally to a printer. The probe was attached to the scanning bridge of a Staveley precision ultrasonic C-scan system (Figure 1).

Figure 1. Eddy Current Scanning System

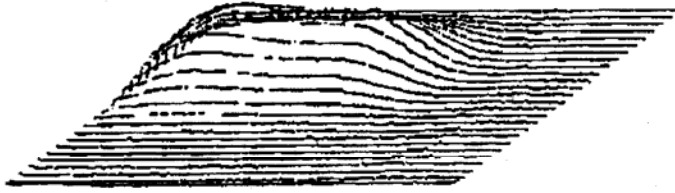
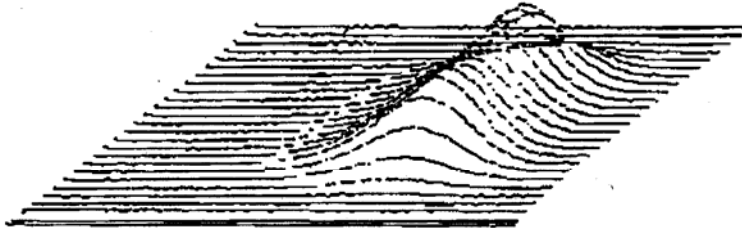
a. LONGITUDINAL SCANS

b. TRANSVERSE SCANS

Figure 3. Eddy Current Scans of 12.54-mm Crack in Specimen J71

The isometric C-scans in Figure 2 provide useful qualitative information but do not provide quantitative data that can be compared. Therefore, each notch and crack was scanned both transversely (across) and longitudinally (along the length). Typical results from the 2.54-mm-long fatigue crack are shown in Figure 3. The amplitude of the peak signal is recorded in volts, and the general topography of the crack is shown in the longitudinal scan. However, for comparison of results, it was decided to select a single line scan with the highest voltage from each flaw. Before doing this, a 2.54-mm U-shaped notch was added to the specimen to determine if there was any difference between a U-shaped and a semicircular-shaped notch of equal size.

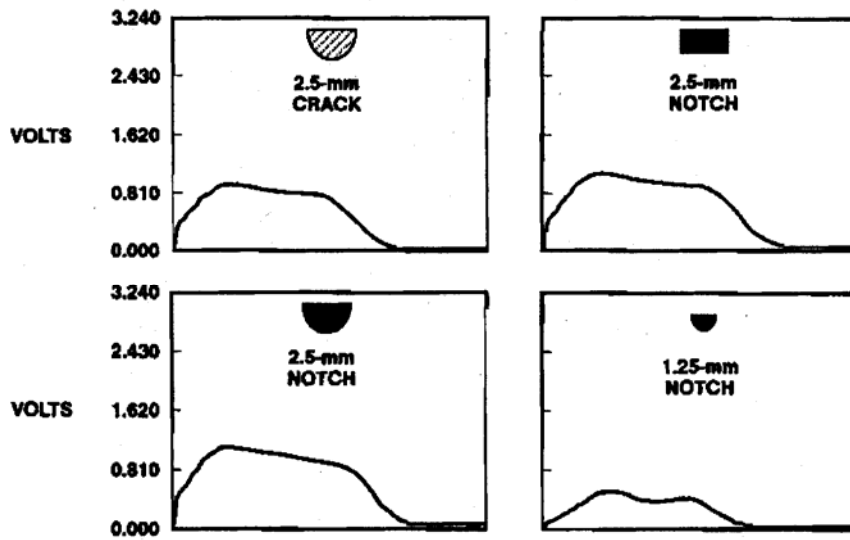
Figure 5. Longitudinal Scans of Notches and Crack in Specimen J71

Figure 4, shows the results obtained from a transverse scan of the three notches and one crack. Figure 5 shows the results obtained from a longitudinal scan of the same flaws.

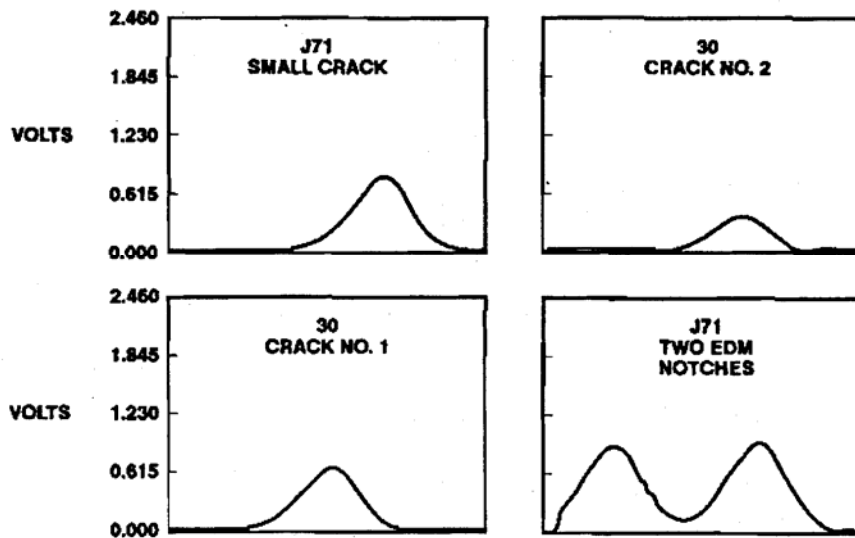
Figure 6. Transverse Scans of Cracks and Notches in Specimens J71 and 30

To obtain additional data, we selected Specimen 30, which contained two cracks. Crack No. 1 was reported to be 2.6 mm long, and crack No. 2 was reported to be 1.0 mm long. Transverse scans, at about 2.5 mm per second, were made of Cracks No. 1 and 2 in Specimen 30 and of the two 2.54-mm notches and 2.54-mm crack in Specimen J71. The results are shown in Figure 6. The peak amplitude of each trace compares favorably with the size of the flaws.

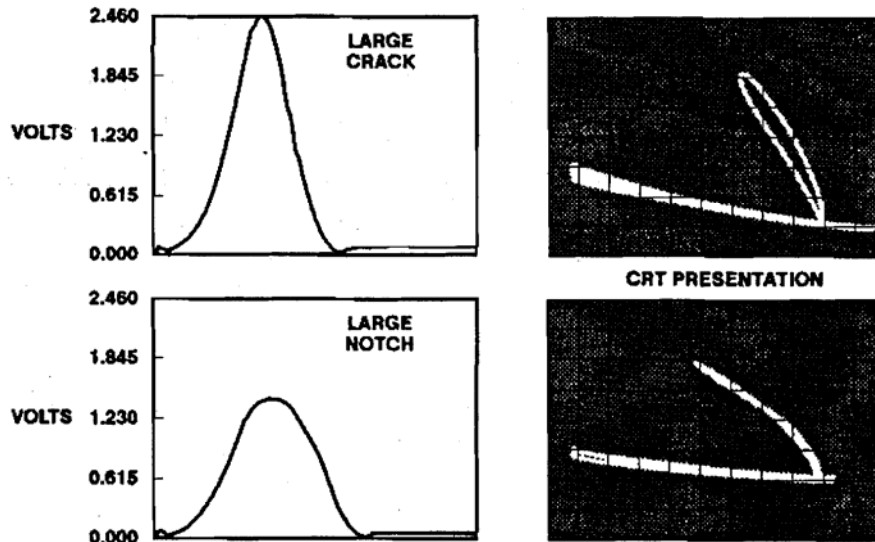
Figure 7. Transverse Scans and CRT Presentations for Large Crack and Notch

All the instrument settings were kept the same when scanning the large crack and notch. The notch was through the thickness (2.0 mm) and 19 mm long. The crack was through the thickness (2.0 mm) and 20 mm long. The natural fatigue crack was closed, whereas the large notch was about 0.25 mm wide. The transverse scans and CRT traces are shown in Figure 7.

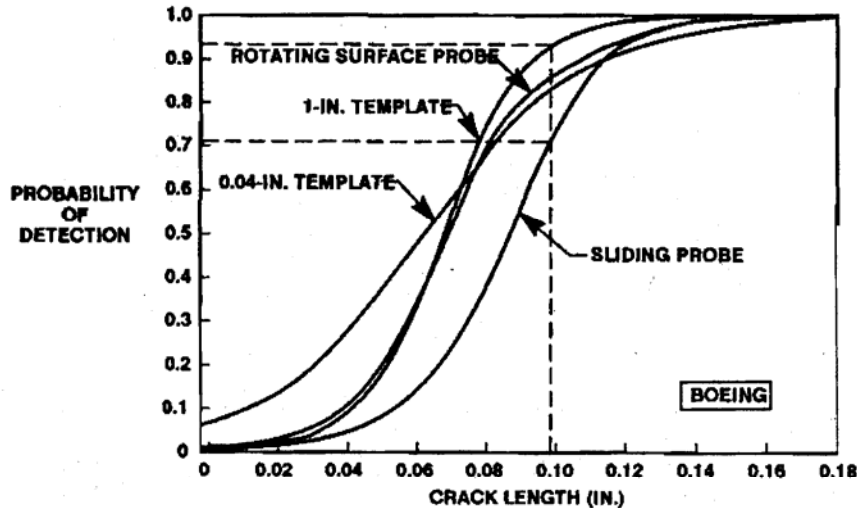
Figure 10. Probability of Detection versus Crack Length

Research). In all cases, researchers have used EDM notches for flaw size evaluations and instrument setup (calibration). In a recent Boeing study,⁽³⁾ where more than 15,000 fastener locations were examined, a probability of detection (POD) was obtained for four techniques (Figure 10). They had naturally cracked panels and EDM notched panels containing flaws ranging from 0.5 to 4.06 mm. The test involved some 20 inspectors. Similar results were obtained in a previous study at Douglas Aircraft Company.⁽⁴⁾
