POD Results: Ultrasonic Inspection of the B-1B Wing Carry Through

As presented at the
ASIP 2004 Conference
December 1, 2004
Memphis, TN

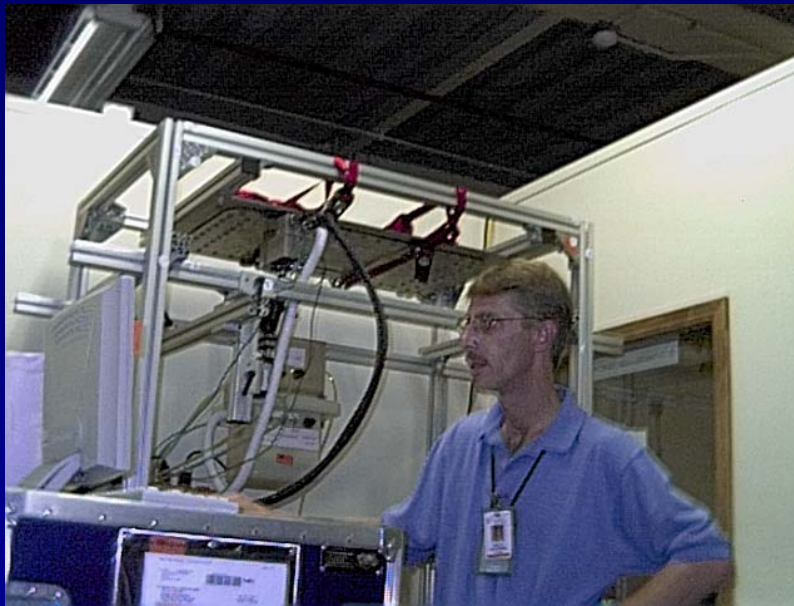
PoD data collection at OO-ALC

- Five inspectors collected PoD data
 - Four at OO-ALC, one at SAIC
