Description of Sandia/AANC Fatigue Crack Samples

Model Assisted POD Meeting

Fatigue Crack Samples

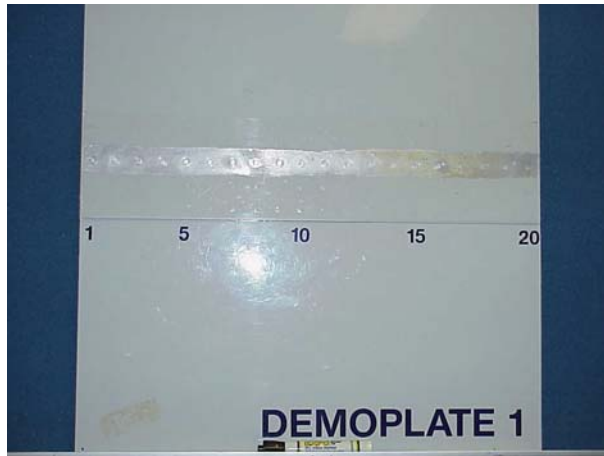
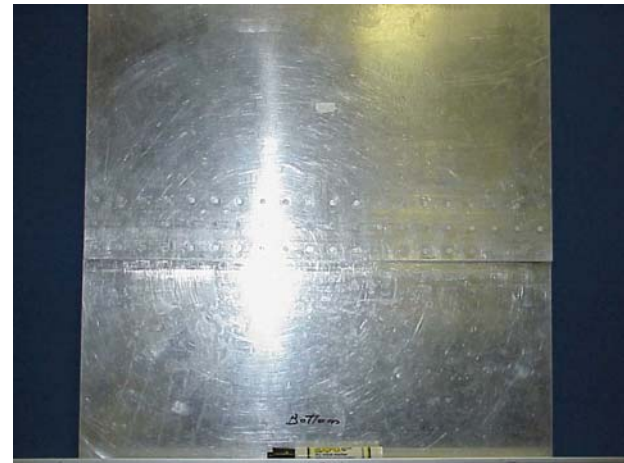
- Two Separate Experimental Panel Sets
 - Eddy Current Inspection Reliability Experiment (ECIRE)
 - Inner Layer Crack Experiment (ILC)

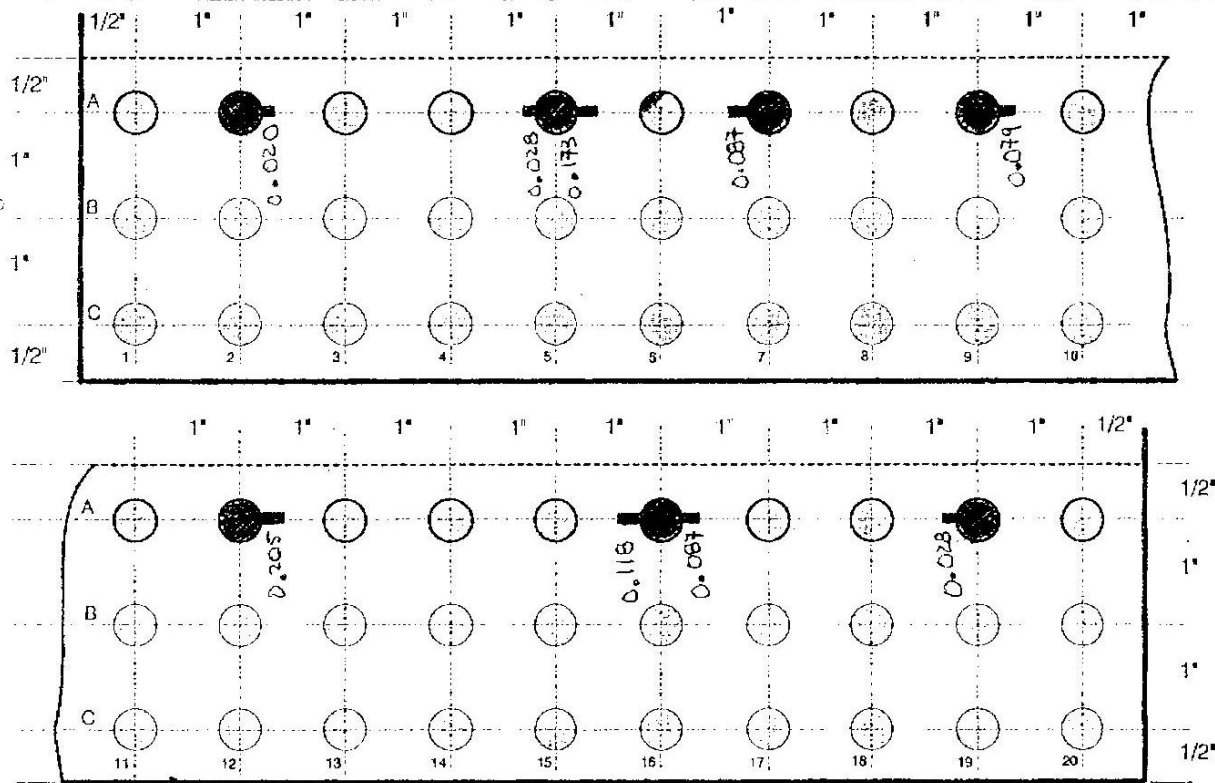
ECIRE Demo Panel #1

PANEL NUMBER: DEMO PANEL #1 $0^{\circ} \pm 5^{\circ}$

1) MATERIAL: 2024 T3

2) SPECIFICATION: QQA 250-5 / AMS 4041

3) SKIN THICKNESS: 0.040"

4) PAINT THICKNESS: 0.004" - 0.005" Upper Row "A"

5) CONDUCTIVITY: 31.6 IACS

6) NUMBER OF CRACKS: 9

Rivet Number	Crack Length (in)	Angle (deg)
2R	0.020	0
5L	0.028	0
5R	0.173	0
7L	0.087	0
9R	0.079	0
12R	0.205	0
16L	0.118	0
16R	0.087	0
19L	0.028	0

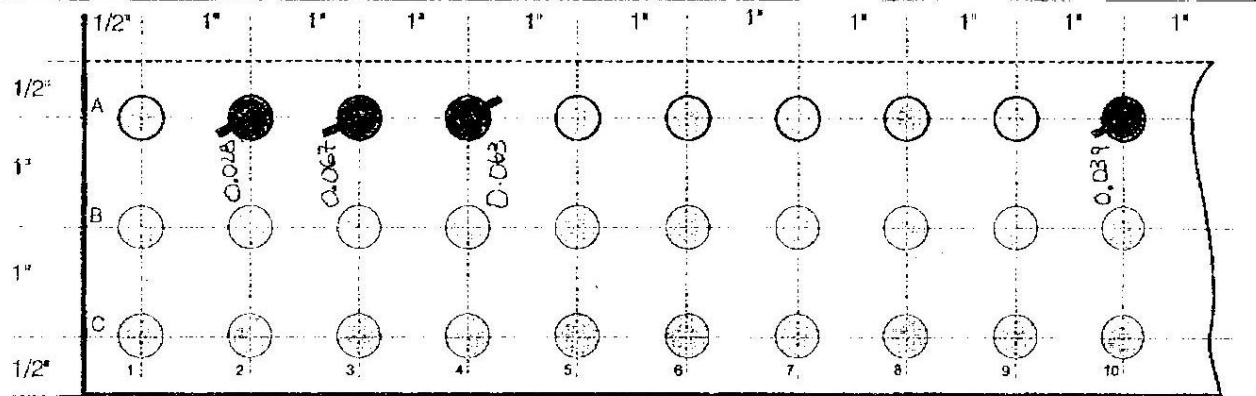
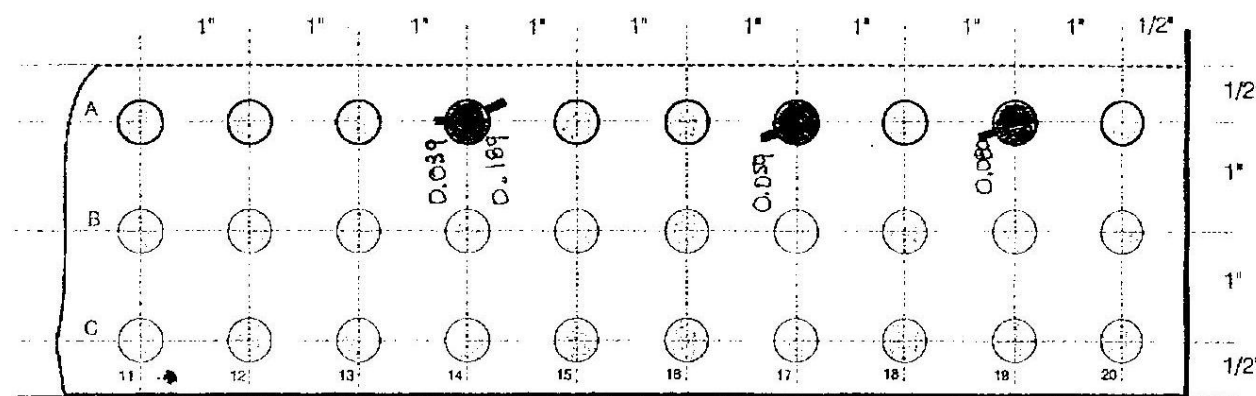
ECIRE Demo Panel #2

PANEL NUMBER : DEMO PANEL #2 22°±5°

| <ul style="list-style-type: none"> 1) MATERIAL: 2024 T3 2) SPECIFICATION: QQA 250-5 / AMS 4041 3) SKIN THICKNESS: 0.040" 4) PAINT THICKNESS: 0.004" - 0.005" UPPER Row "A" | <ul style="list-style-type: none"> 5) CONDUCTIVITY: 31.6 IACS 6) NUMBER OF CRACKS: 8 7) FABRICATION DATE: 26 MAR 1992 8) INSPECTED: R.A. Johns |

Rivet Number	Crack Length (in)	Angle (deg)
2L	0.028	-22
3L	0.067	-22
4R	0.063	+22
10L	0.039	-22
14L	0.039	0
14R	0.189	+22
17L	0.059	-22
19L	0.080	-22
